### Analysis of the failure of a PPS polymer cycling support: Microscopy and Finite Element studies

J. Marsh, R.P. Turner\*, M. Wang and M.J. Jenkins

School of Metallurgy & Materials, University of Birmingham, Edgbaston, Birmingham, United Kingdom B15 2TT

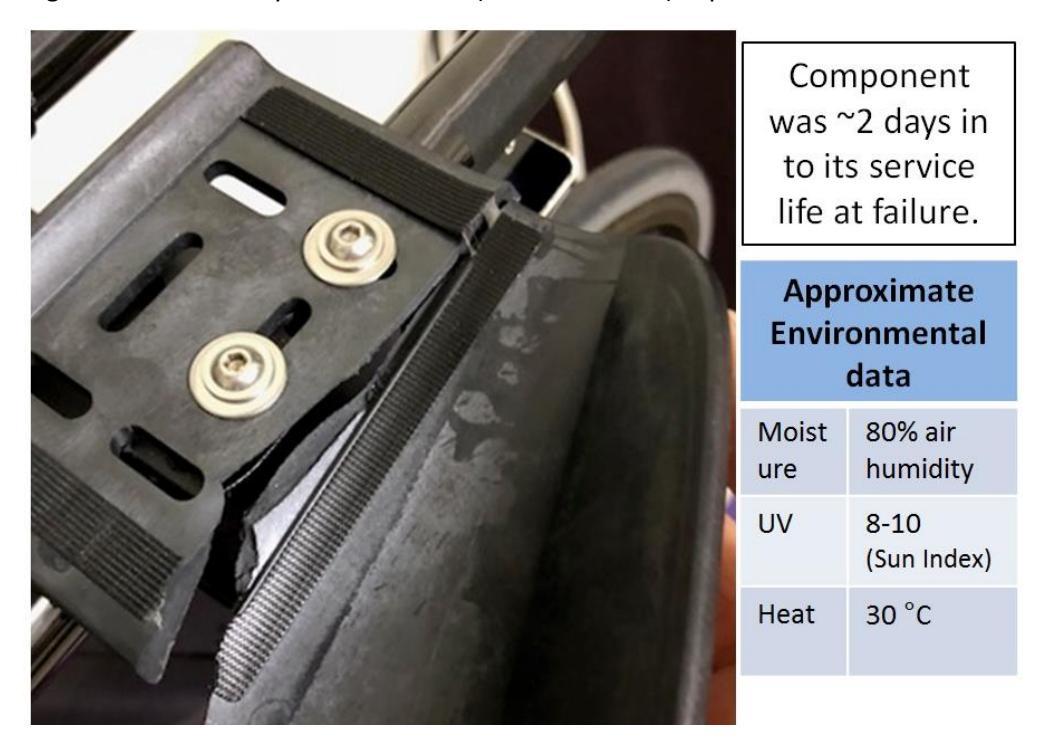
A cycling arm-rest component fabricated from the reinforced PPS using injection moulding methods was used for its intended application by a cyclist. The component was brand new, and fitted to the bicycle in its as-received condition. However the component suffered a sudden failure within days of being first attached and used, with a crack propagating through the component and causing the arm-rest to break in two (see **Figure 2**). Due to the component failing so shortly after first being attached to the bicycle, the failure was not considered to be caused in any way by PPS material surface degradation caused by environmental (UV or moisture) exposure.

*Figure 2*: *Fractured component mounted on the handlebars*

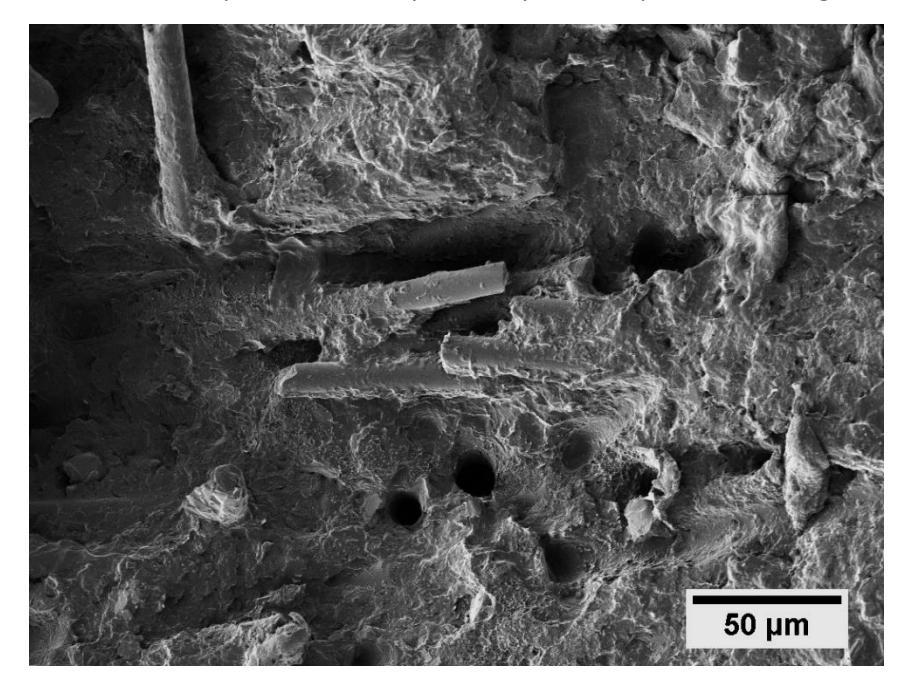
Figure 4: SEM image at the fracture surface of the component at 500x magnification

An important aspect of composites created from a polymer and fibre is the adhesion between the fibre and the matrix. Poor adhesion can result in small micro-voids forming, and this may result in stress concentration sites between the two materials. **Figure 4** shows an SEM image of the fracture surface where the fibres show reasonable embedding in the matrix, with no obvious visible voids between the fibres and the matrix. The light grey cylinders represent the glass fibres, of an average length of ~50  $\mu$ m, within the dark grey PPS polymer matrix. Some evidence of fibre pull-out from the matrix is also observed – these being the two exposed holes in the matrix where fibres used to be embedded.

However, under mechanical loading such as the in-service conditions of this component with the forces applied by the cyclist, the distribution of the loading across the fibres and the matrix needs to be considered, which in turn depends upon fibre orientation [16] The fact that this component is produced with short fibres allows it to be isotropically strong. This would suggest that during normal service loads below the material yield strength, the reinforced polymer would allow for a rebalance of the forces transmitted via the fibres and the matrix in proportion with the strength of the separate phases such that the imparted strain is constant across the two, thus the two phases of the composite remain fully aligned, with no delamination.

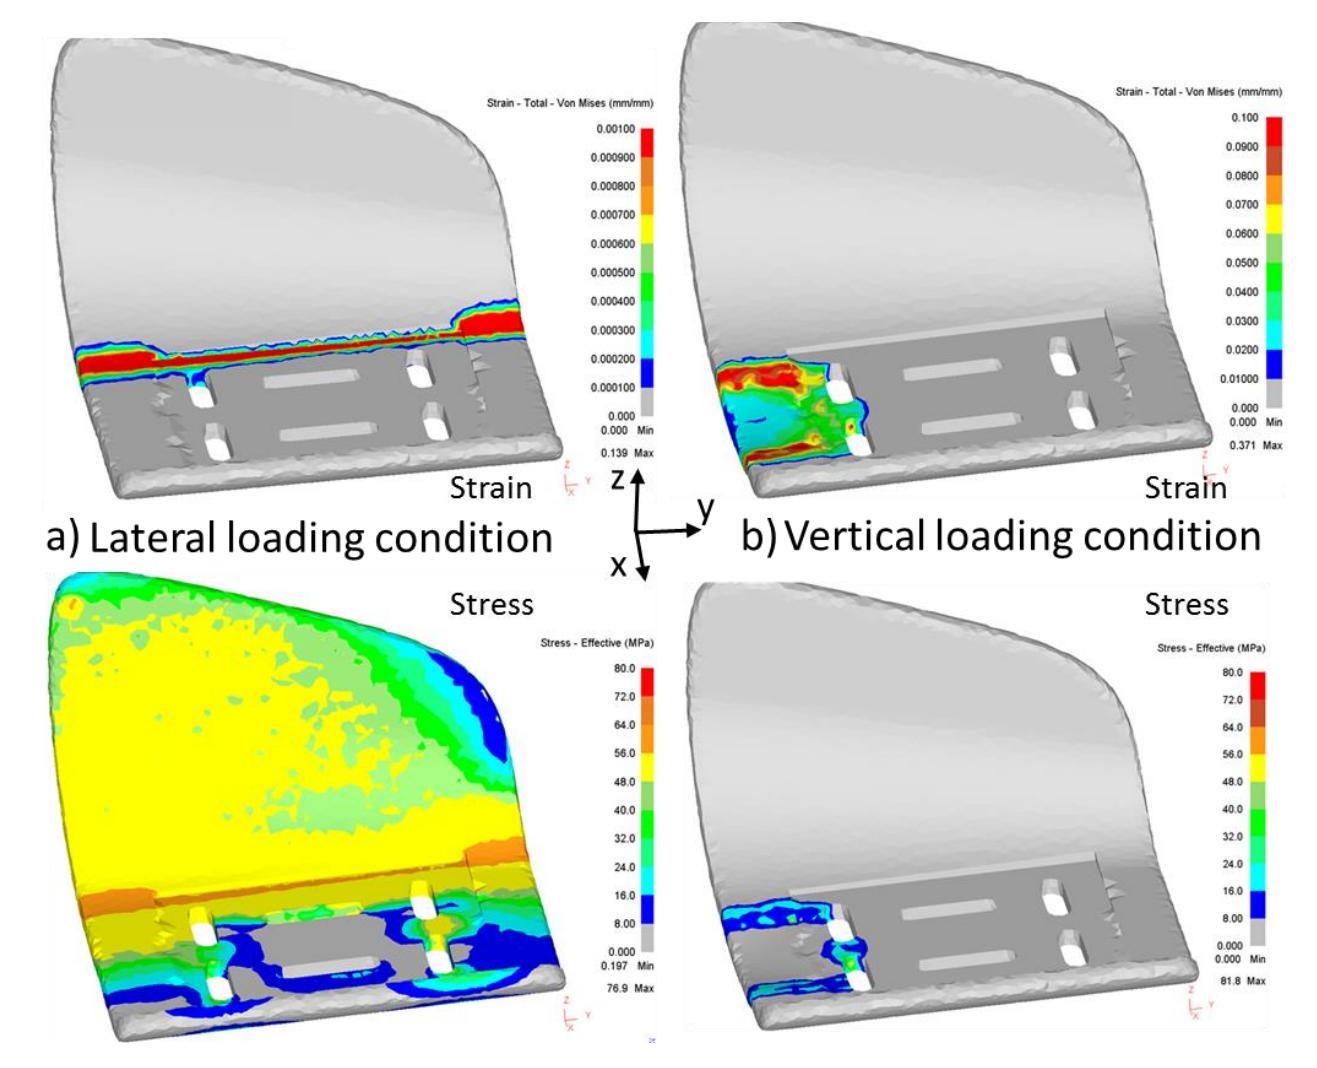
The FE modelling framework to simulate in-service loadings upon the component for the two loading scenarios considered were performed in FE software Deform v11.1. The outputted predictions for the total strain and the effective (von Mises) stress are presented in **Figure 7.** It can be observed from the predicted strain and stress fields (see **Figure 7a**) that for the lateral loading condition the highest regions of effective (von Mises) stresses and effective strains accumulate along the sharp radius of the recessed flat base section of the component. The von Mises stress values are peaking at approximately 60-70MPa according to FE predictions, which is not of concern given the strength of the material in different loading scenarios ranges from 145-180MPa.

Figure 7: FE predictions for plastic strain and Effective stress fields under the two loading conditions

It is hypothesised that at the moment of failure the component experienced abnormal loading, potentially caused by an uneven road surface which may have induced a mechanical shock in to the system. Mechanical shock is a sudden acceleration caused by impact of an object external to the system [17]. Thus, the forces experienced by the component at the instance of fracture may not simply be produced by the mass of the rider under gravitational acceleration, but now are the summation of this internal system force and the external (mechanical shock) force applied due to the acceleration. The more sudden the shock is, so the acceleration increases and thus so does the force upon the component. It has been demonstrated in the literature that even relatively small impact can produce considerable shock when the time-frame is short [17-18]. The inclusion of mechanical shock will likely have a dual purpose upon the component system, firstly the rider in this situation is highly likely to push out their arms further than usual, exacerbating the lateral loading upon the component. Secondly, the summation of the forces acting upon the component at the critical regions along the sharp corner and in-between the affixing holes will now potentially exceed the loading applied by the rider alone.

However, this will force the component to flex along this corner placing one surface in to tension and the other in to compression, providing a potential driving force for any accumulation of damage and cracking to propagate entirely along the recessed section radius. By comparing to the real component that suffered sudden-onset failure (shown in **Figure 2**), it can be clearly observed that the crack path propagated along much of the sharp-radius corner of the recessed base section where it meets the curved wing. It is therefore highly likely that the driving force to exacerbate the crack propagation came from a lateral force as the cyclist's arm slipped during service.

Whereas, when the component is subjected to the vertical loading condition, a small location of high von Mises stress and strain accumulates in between the two affixing holes within the component closer to the vertical force provided (see Figure 7b) and around the radii of these two affixing holes. The region in-between the affixing holes will likely be subject to crack propagation driving forces associated with regions of high stress, and potentially this just requires an initiation site to provide potential failure. As described previously, characterisation and analysis of the fractured component was carried out using Micro CT. These experiments provide detailed information about the internal structure of the component. The bulk component was observed as a dense solid with no sporadic voids visible confirming complete filling of the mould during manufacture. However, a single void in the component was clearly visible in the Micro CT scan along the surface of the crack (Figure 8).

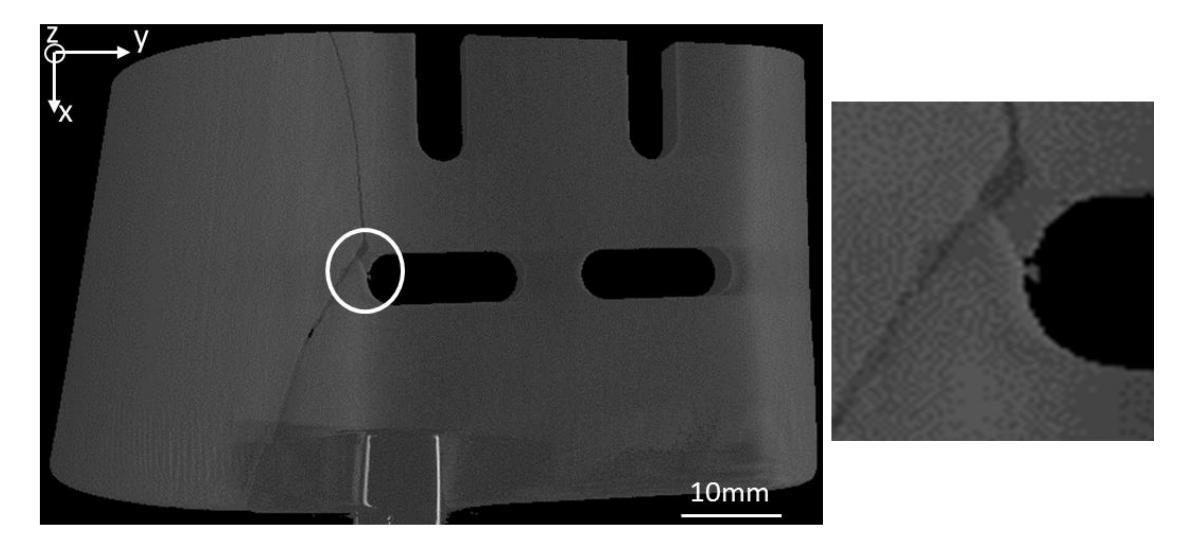
*Figure 8*: Micro CT image of a void on the crack interface within the component. An additional crack is indicated as another region of interest (circled) and is zoomed in on the right

This void, due to the location of the actual crack surface may be a consequence of either; a) the component fracture and a subsequent loss of material in this location due to damage accumulation, or b) an incomplete moulding process leaving a residual void prior to the component failure. The location of the void - well away from any sharp or small features which may restrict the flow - would likely not suggest an incomplete mould operation and thus the observed void probably a result of the loss of material due to high localised damage at the onset of cracking. However, the direction of the crack from the fixing hole to the void would suggest that a weak point may have been present prior to the sudden-onset failure of the component.

Also observed within **Figure 8** is a crack emanating from the left edge of the left affixing hole, and which joins the main crack which propagated through the component. This crack observed with Micro CT methods is noted to match a location of increased stress and strain from the FE predictions for the vertical loading arrangement. Although the highest region of stress and strain was on the other side of the affixing hole, in the region of material between the two, the presence of the through thickness main crack may have changed stress fields in the component, if we assume this is a subsequent crack. Alternatively, this small crack leading from the affixing hole to the main crack may be another potential nucleation site for the sudden failure, although this seems more unlikely.

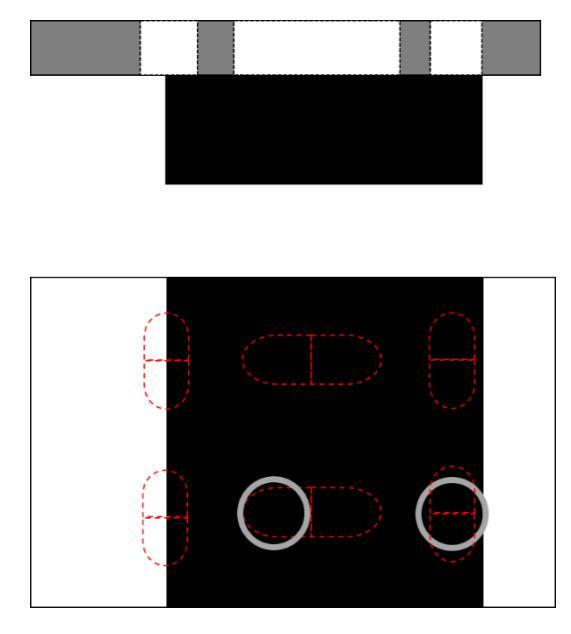
Finally, the location of the arm rest upon the customer-mounted supporting aerobar was believed to influence the failure of the component in this instance. The location of the supporting bar can be varied to accommodate the riders shape, size and riding preference. Two bolts are used to secure the arm rest. The user can choose from the available six affixing holes manufactured in to the component. The two affixing holes used to support this fractured component are shown in **Figure 9** (represented by the grey circles) from a choice of the six available (represented by the dotted lozenges). The black rectangle represents the support that was situated between the bar and the arm rest. It can be observed that the unused horizontal pair of affixing holes on the left of the image is situated on the very edge of the supporting bar. In this configuration, it is likely that the overhanging region acts as a lever for the loading to be applied and with the fulcrum across the centre of the fixing holes where there is a reduced amount of material.

*Figure 9*: The arm rest location mounted on the aerobar support.
