## Investigating the relationship between trenching practice and road deterioration using a field trial

**Title: Investigating the relationship between Trenching Practice and Road Deterioration using a Field Trial**

A fully instrumented site trial was undertaken where two pipes were installed using trenching in a road, with one reinstated according to the higher end of the UK specification and the other on the lower end of the specification. The trench reinstated according to the lower end of the specification experienced serviceability failure, where large settlements (approximately 70 mm) and deflections (up to 2000 microns) were observed. The other trench also experienced distress, although to a much reduced level. This demonstrates that trenching, even when reinstated according to the higher end of the specification, still weakens the existing road locally.

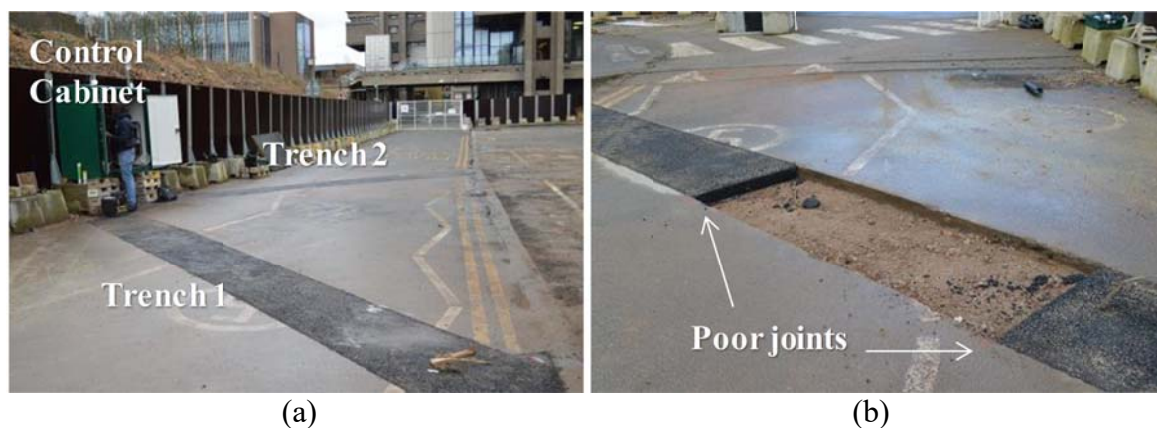
Figure 2 shows the reinstated trenches, excavated in a V-shape in plan so that a single control station could be used and to minimise the length of cabling. The dimensions of each trench were: 8 m long, 0.9 m wide and 0.8 m deep. High-density polyethylene plastic (HDPE) pipes,

The joints between the Trench 1 constructed trench and the existing road were not sealed (Figure 2b), while these joints for the Trench 2 were sealed using over-banding tapes and painting the trench walls with bitumen. Additional poor joints were created on the Trench 1 constructed trench by laying a middle section with vertical edges, rather than the recommended stepped overlapping joints, again without using any over-banding tape.

**Figure 2: (a) The two reinstated trenches and (b) construction of the poor joints**

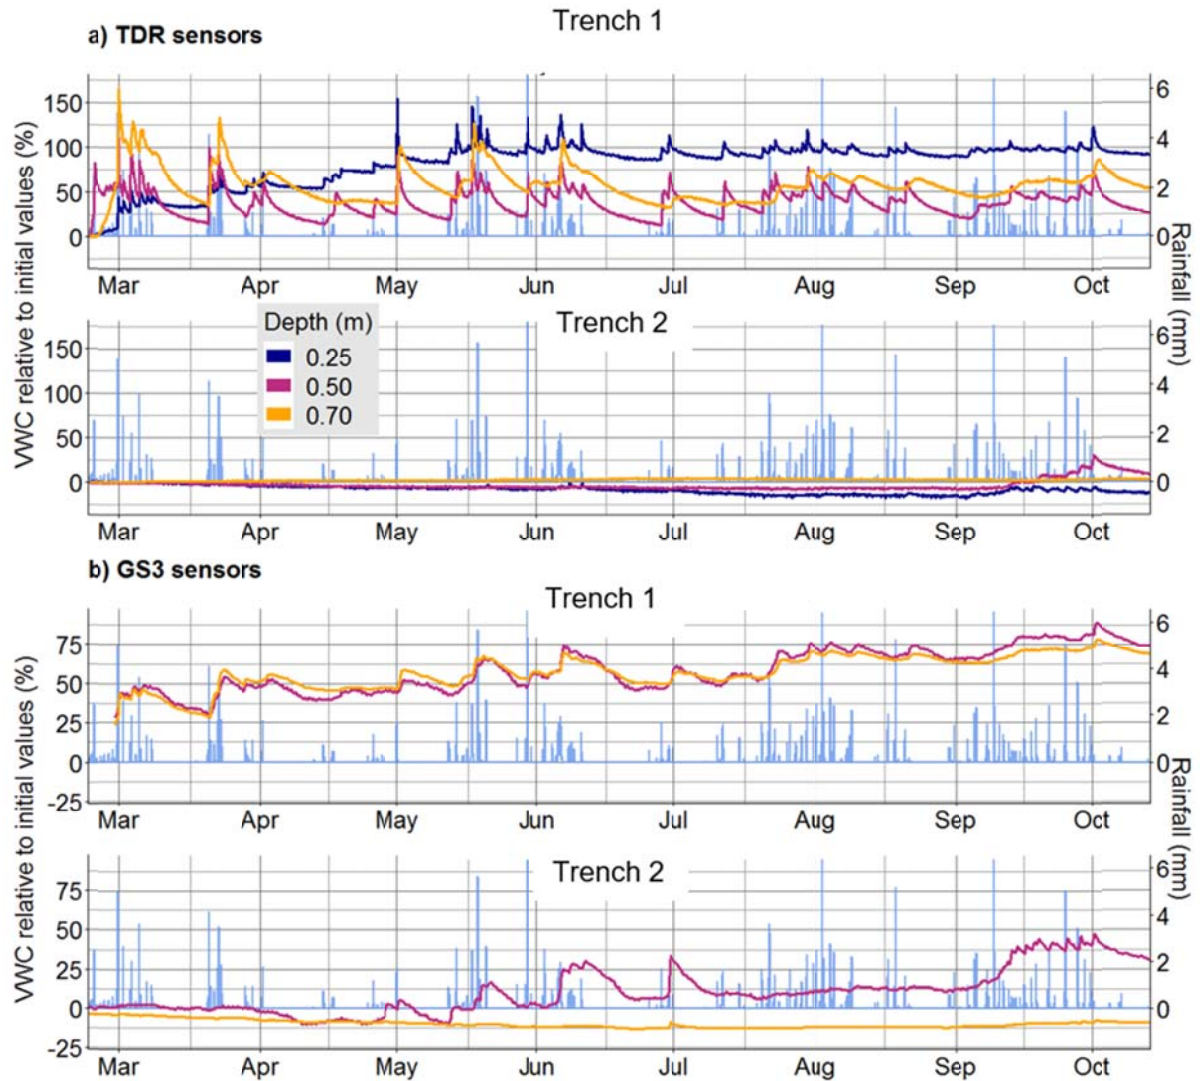
During the monitoring period, no snow precipitation occurred, but a number of rainfall events were recorded with a maximum daily precipitation of between 6 and 7 mm on three occasions (Figure 6). The volumetric water content (VWC) measured by the TDR and GS3 sensors are shown in Figure 6a and b, respectively, at different depths relative to the initial values measured soon after installation. Clearly these results show a significant difference in the infiltration rates, with smaller water content variations in Trench 2 (typically well below 50 % relative change) and significant changes corresponding to rainfall events in Trench 1 (sometimes of over 100 % relative change and regularly affected by rainfall events). The difference in water content between the two trenches, which can be seen from the start of the trial, is an indicator of the significant negative impact of unsealed joints.

The use of relative values was preferred as this provides a better indication of the variation. However, the measured VWC by the two sensor types did not always match due to the different operating principles and the heterogeneous nature of the soil. With respect to the relative measurements presented, it is interesting to note that the TDR measured sharper spikes corresponding to rainfall events in Trench 1 and approximately constant values in

Trench 2 except in October when some water reached the probe at 0.50 m depth (Figure 6a). The GS3 sensors buried at 0.50 m depth in Trench 2 measured clear variations in VWC throughout the monitoring period, although the magnitude of the changes was typically smaller than the changes recorded in Trench 1 (Figure 6b). It is possible that water reached the location of this sensor through a preferential water path (possibly laterally). An alternative hypothesis is that the road above the sensor started to degrade due to traffic loading and associated cracks and small defects were responsible for that water change (some surface damage was indeed observed visually during site inspections in May). As discussed later, vehicles started moving regularly across the site from the 18<sup>th</sup> of April and the larger variations measured by this sensor were subsequent to this date (Figure 6b).

**Figure 6: Volumetric water content (VWC) change relative to the initial values measured soon after trench reinstatement obtained from (a) TDR sensors and (b) GS3 sensors installed at different depths. (Note the black vertical lines indicate the rainfall events)**
