## Automated detection of cracks in roads using ground penetrating radar

Eskandari Torbaghan, Mehran; Li, Wenda; Metje, Nicole; Burrow, Michael; Chapman, David; Rogers, Chris

DOI:  
[10.1016/j.jappgeo.2020.104118](https://doi.org/10.1016/j.jappgeo.2020.104118)

*Citation for published version (Harvard):*  
Eskandari Torbaghan, M, Li, W, Metje, N, Burrow, M, Chapman, D & Rogers, C 2020, 'Automated detection of cracks in roads using ground penetrating radar', *Journal of Applied Geophysics*, vol. 179, 104118.  
<https://doi.org/10.1016/j.jappgeo.2020.104118>

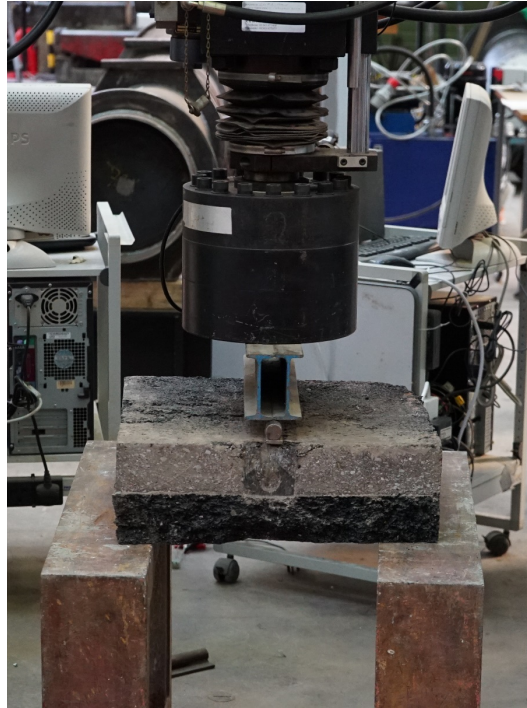
To examine the feasibility of GPR to detect surface cracking in pavements, seven asphalt slabs were cast. The asphalt slabs had overall dimensions of 500 mm × 500 mm × 110 mm (depth), the latter dimension being the minimum recommended thickness for the surface layer of a road pavement, e.g. Kent County Council (2000). Cracks ranging in width from 1 mm to 32 mm were created in the slabs using an actuator to apply a load of up to 70 kN (Figure 1). All cracks

**Figure 1: Crack simulation process using an actuator**

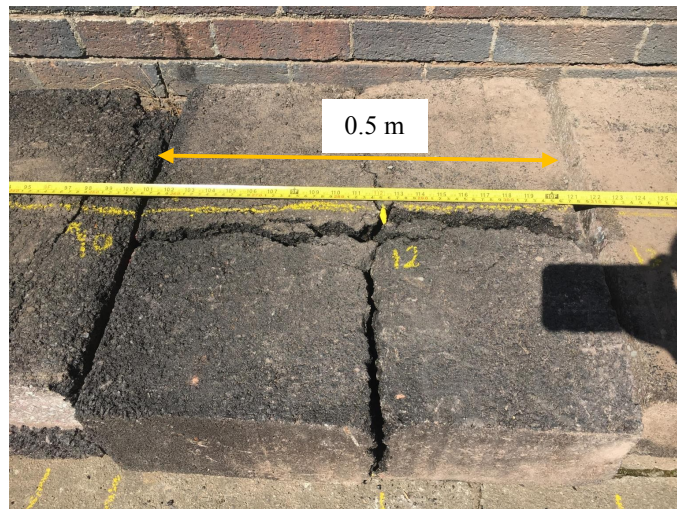
penetrated the surface and the crack depth was 110 mm throughout. An example of the resulting cracked asphalt pavement is shown in Figure 2.

**Figure 2: One of the tested asphalt slabs**

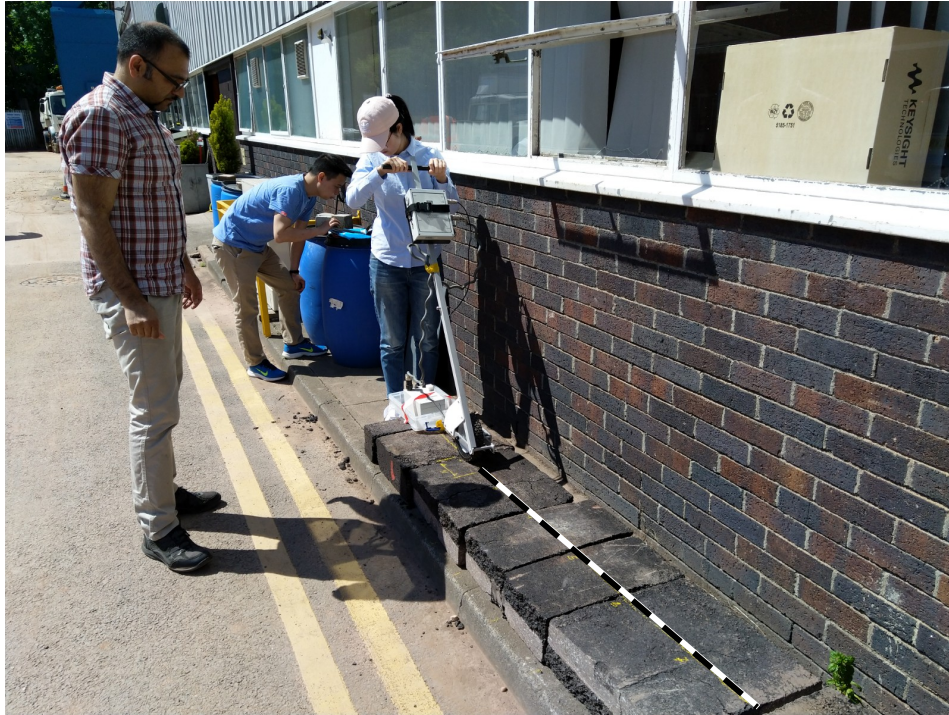
During the tests, the GPR unit was moved along the centre line of the lined slabs (the dashed line in Figure 3) at walking speed. This meant that crack detection was only attempted in the transverse direction to the travel of the GPR unit.

**Figure 3: GPR unit traversing the cracked asphalt specimens**
