Automated detection of cracks in roads using ground penetrating radar

Eskandari Torbaghan, Mehran; Li, Wenda; Metje, Nicole; Burrow, Michael; Chapman, David; Rogers, Chris

DOI:
[10.1016/j.jappgeo.2020.104118](https://doi.org/10.1016/j.jappgeo.2020.104118)

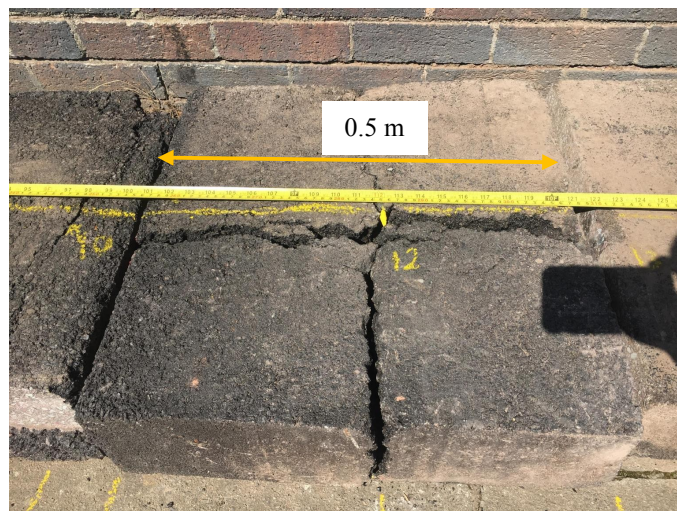
penetrated the surface and the crack depth was 110 mm throughout. An example of the resulting cracked asphalt pavement is shown in Figure 2.

Figure 2: One of the tested asphalt slabs
