### Analysis of the failure of a PPS polymer cycling support: Microscopy and Finite Element studies

J. Marsh, R.P. Turner\*, M. Wang and M.J. Jenkins

School of Metallurgy & Materials, University of Birmingham, Edgbaston, Birmingham, United Kingdom B15 2TT

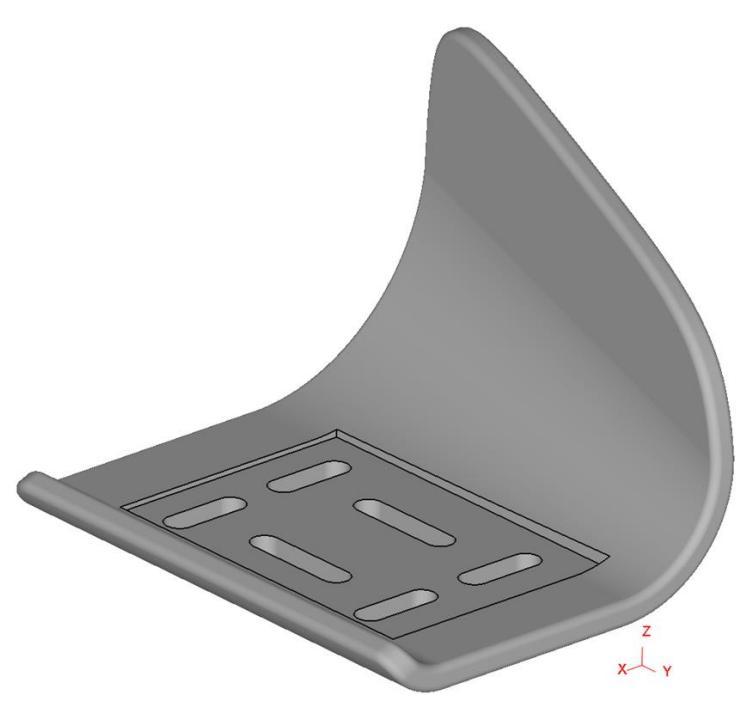
Figure 1: CAD imaged model of the arm rest component

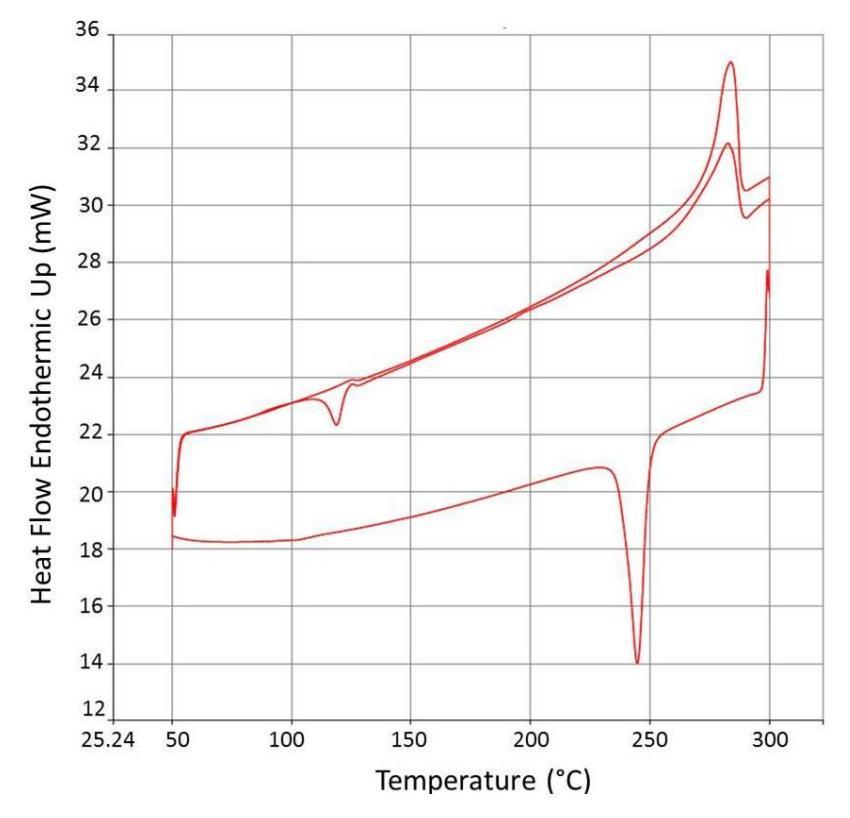
A Perkin Elmer DSC7 was interfaced with a personal computer to measure thermal properties of the composite. The differential scanning calorimeter (DSC) was calibrated using known masses of indium (99.999% pure) and tin (99.999% pure). The composite sample of PPS GF30 (30% glass fibre) was tested using a DSC to determine its thermal properties. A 17 mg sample of PPS was subjected to a heat-cool-heat scan between 50 and 300°C at 10°C/min. Crystallisation and melting temperatures were recorded as 282.9 and 244.8°C respectively. Injection moulding components are cooled rapidly to increase production. This rapid cooling prevents the completion of non-isothermal crystallisation. An exothermic peak at 118.9 °C shows this incomplete crystallisation during manufacture (see **Figure** 3). The mechanical properties for the reinforced PPS material were obtained from the literature [15], and can be seen in **Table 1**.

Figure 3: DSC trace of PPS GF30

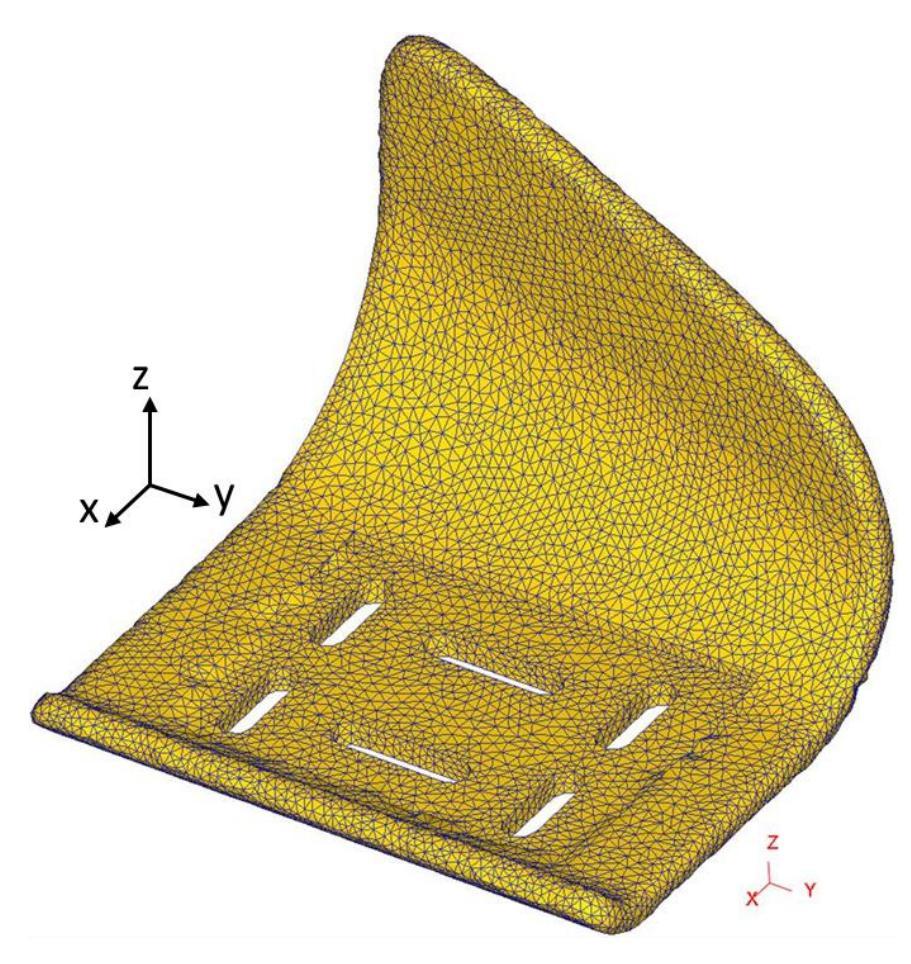
A finite element (FE) model was created, using general Finite Element solver Deform v11.1, to better understand the plastic strain and residual stress fields developing within the component, during the loading scenarios that were considered likely based upon the service and the crack surface. The model was constructed from the .step CAD files provided by the manufacturer. The model was setup in a full three-dimensional environment and computed on a 48Gb RAM, 8-core workstation – although the model was run only on a single core. The model was meshed using the standard tetrahedral meshing application of the DEFORM v11.1 code. The mesh that was used contained a reasonably uniform mesh density - although automatic meshing refinement produced finer elements at sharper radii of the component geometrical features - with approximately 100,000 tetrahedral elements, and with an approximate meshing element length of 1.5mm. The applied mesh can be seen in **Figure 5**.

*Figure 5*: The cycling support arm-rest component, imported in to FE software Deform v11.1 and meshed with the automatic meshing tool

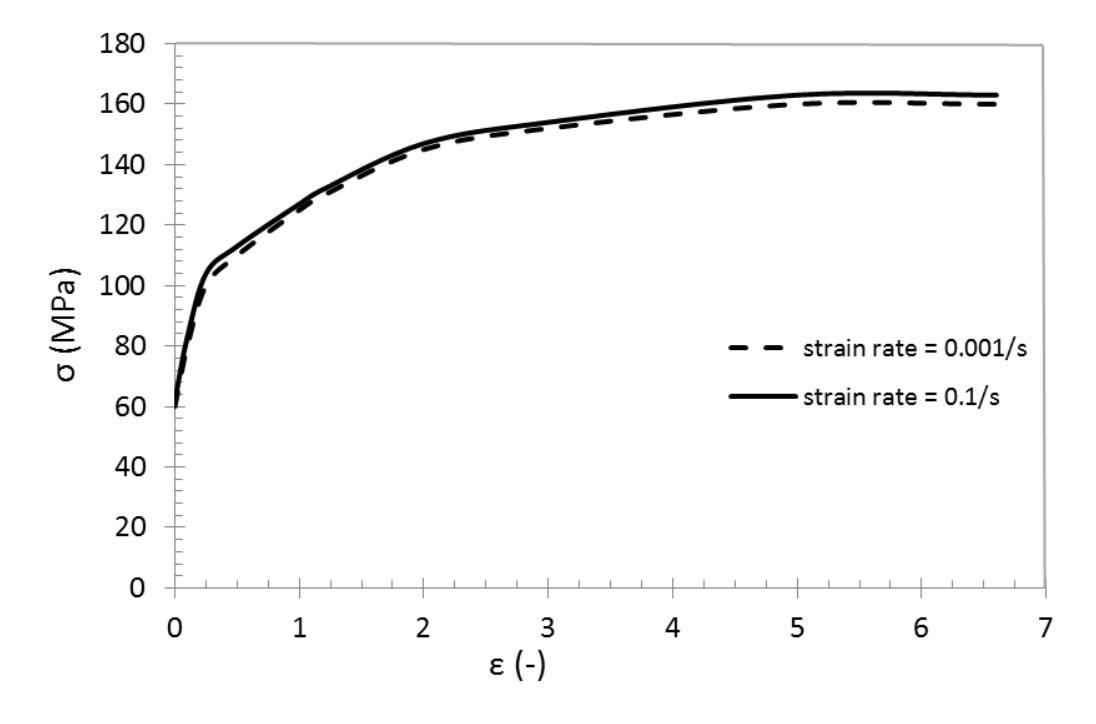
Figure 6: Stress-strain graph of PPS GF30 at a strain rate of 0.001 and 0.1/s
