Aging of lime-based TRM composites under natural environmental conditions

Dalalbashi, A.; Ghiassi, B.; Oliveira, D.V.

DOI: 10.1016/j.conbuildmat.2020.121853

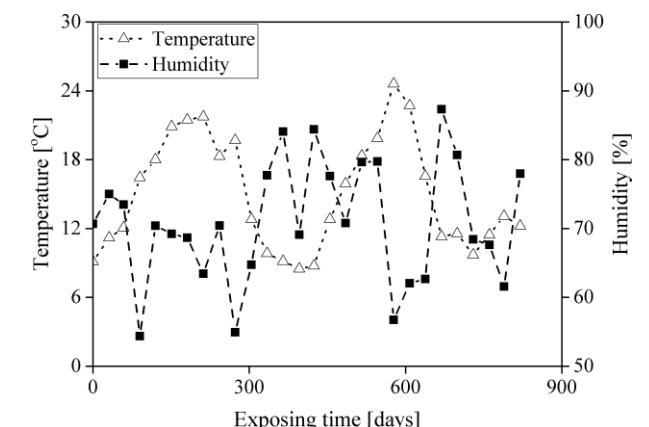
Exposing time [days] Fig. 1. Changes of the temperature and humidity of air at Guimarães region during outdoor exposure conditions.

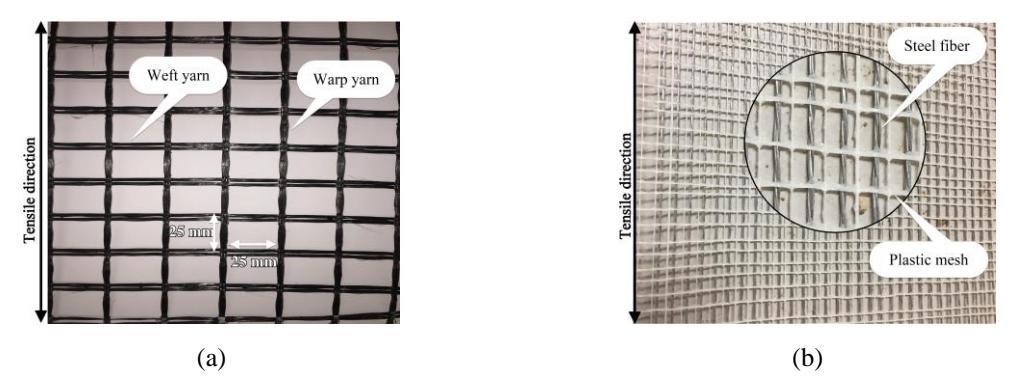
Fig. 2. Fiber configuration: (a) glass mesh; (b) steel mesh.

The glass fabric (Fig. 2a) was a woven biaxial fabric mesh made of alkali-resistance fiberglass [32]. Its mesh size and area per unit length were equal to 25 mm×25 mm and 35.27 mm²/ m, respectively, according to the technical datasheets. The steel fiber (Fig. 2b) was a unidirectional ultra-high tensile steel sheet [33], with a density of 670 g/m², an effective area of one cord (five wires) equal to 0.538 mm², according to the technical datasheets. Each fiber was made by twisting five individual wires together, three straight filaments wrapped by two filaments at a high twist angle, forming a uniform cord.

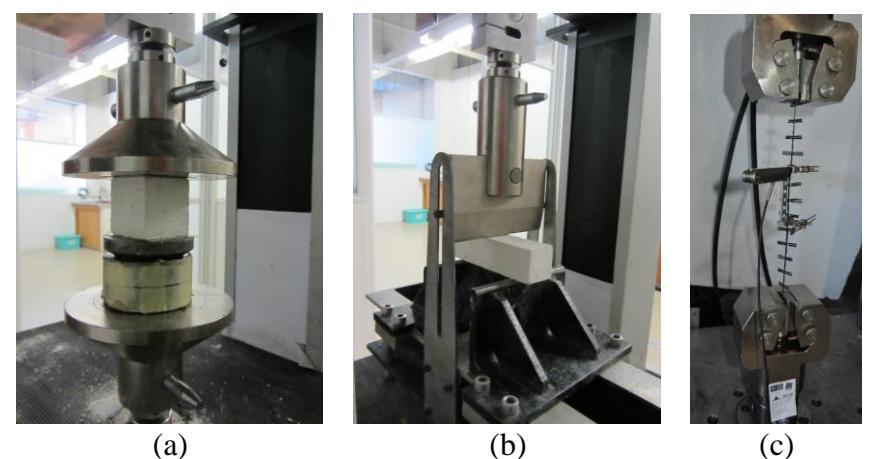
(a) (b) (c) Fig. 3. Mechanical characterization tests: (a) compressive mortar test; (b) flexural mortar test; (c) fiber direct tensile test.

6 The tests were performed by using a Lloyd testing machine under load-controlled conditions 7 at a rate of 150 N/s (for compressive tests) and 10 N/s (for flexural tests), as shown in Fig. 3. 8 In the compressive tests, for reducing the friction, a pair of Teflon sheets and oil was placed 9 between the specimen and the compression plates (Fig. 3a). The flexural tests were performed 10 in three-point bending test scheme with a 100 mm distance between the supports (Fig. 3b).

To obtain the tensile strength and elastic modulus of fabrics, a single roving was tested under direct tensile tests. A universal testing machine with a maximum load capacity of 10 kN was used for these tests. The tests were conducted under displacement-controlled conditions at a rate of 0.3 mm/min (Fig. 3c). The free length of the textile for all test specimens was equal to 300 mm. A 100 mm clip gauge located at the center of the specimens and the internal LVDT sensor of the machine measured the fiber deformation along with the tests, as shown in Fig. 3c.

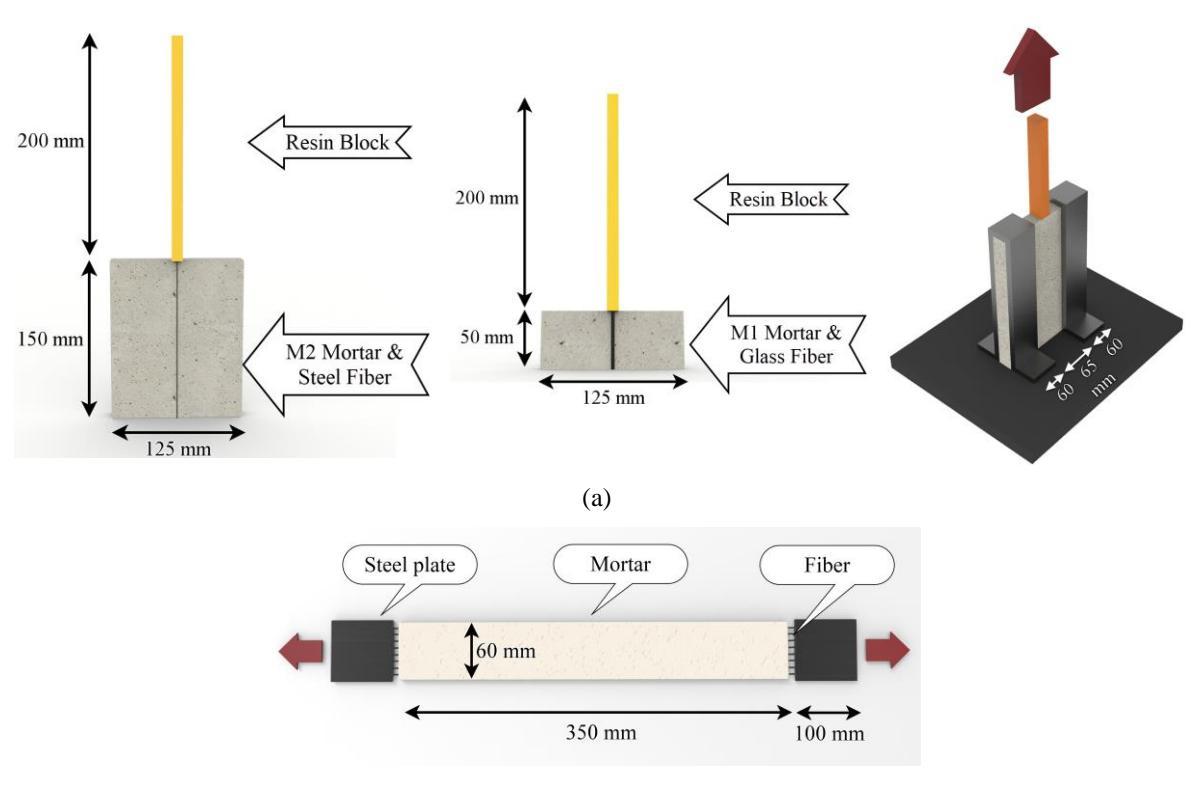
Fig. 4. Specimens' configurations and corresponding test setups: (a) pull-out test; (b) tensile test.

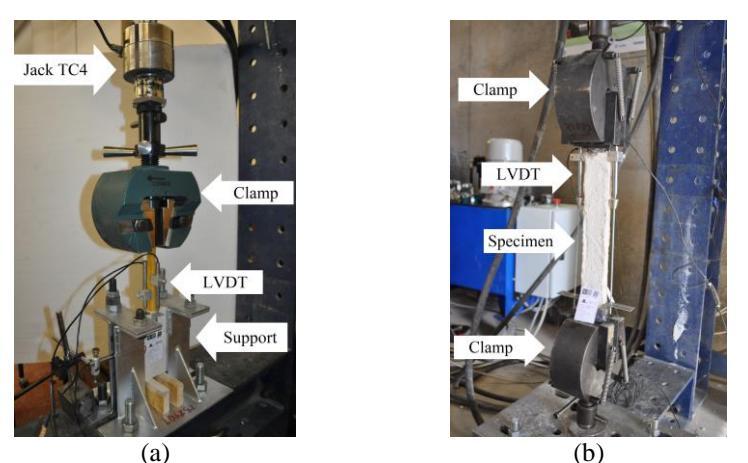
(a) (b) Fig. 5. Test setups and instrumentation used: (a) pull-out test; (b) tensile test.

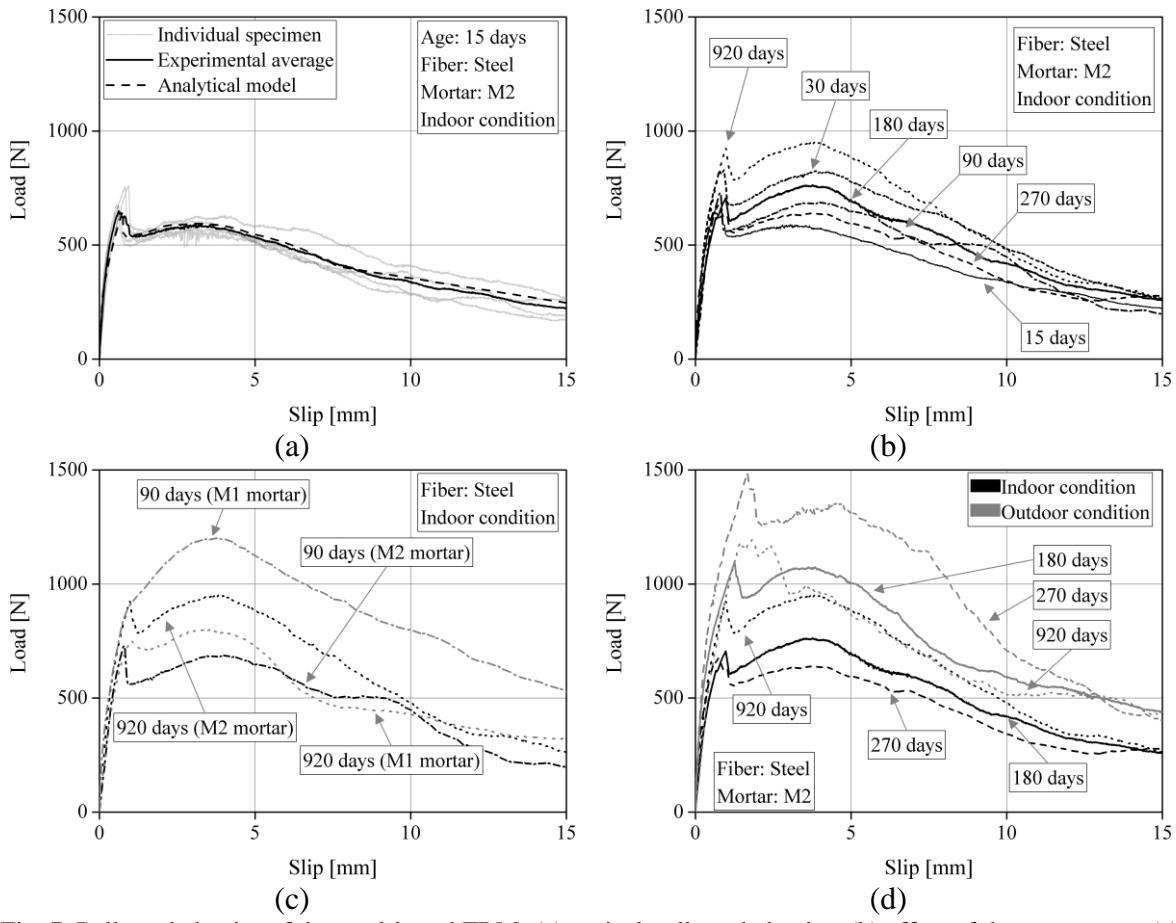
Fig. 7. Pull-out behavior of the steel-based TRM: (a) typical pull-out behavior; (b) effect of the mortar age; (c) effect of the mortar type; (d) effect of environmental condition.

The failure mode for all the specimens is fiber slipping/pull-out from the mortar. The pull-out curves at all ages show the typical linear, nonlinear, and dynamic stages with a drop of the load after the peak load (see, for example, the results obtained from samples tested at 15 days in Fig. 7a). This sudden drop load shows the transition from chemical/frictional bond to frictional bond and indicates that the frictional bond is smaller than the adhesive bond in this system [39,42,44,46,47]. After this load drop, a slip hardening behavior (forming a second peak load) and then a softening response until the end of the tests is observed [39,44,47–50].
Comparing the load-slip curves of the samples tested at different ages under indoor conditions,
Fig. 7b, shows that in general, the bond behavior is improved with time even until 920 days,
a slight decrement of bond performance is also observed at some ages. This behavior is

6 The role of the mortar type seems to be significant for the bond performance of indoor aged 7 samples, as shown in Fig. 7c. Specimens prepared with M1 mortar show a better bond 8 performance at 90 days but a worse one at 920 days than specimens prepared with M2 mortar. 9 It seems that although pull-out samples prepared with M1 mortar gain higher strengths in early 10 ages, bond deterioration or mortar shrinkage in longer ages governs their performance at later 11 ages. Also, a comparison between the pull-out response of M1 mortar at 90 and 920 days 12 shows (Fig. 7c) that the transition from the progressive debonding stage to the dynamic stage 13 has changed from a smooth and upward trend to a sudden drop in the pull-out load.

14 Comparing the pull-out curves of indoor and outdoor aged samples (made of M2 mortar), Fig. 15 7d, shows that generally, outdoor aged samples have a better bond performance. This 16 observation can be due to a higher hydration degree achieved in the samples aged under 17 outdoor conditions. Clearly, hydraulic lime-based mortars aged under indoor conditions have 18 a considerably slower hydration degree and thus the bond performance. The peak load of 19 samples aged (at 920 days) under outdoor conditions is 1125.9 N, which is 1.19 times that of 20 samples aged under indoor conditions. It should also be noted that samples aged under outdoor 21 conditions reached a peak load of 1550.3 N at 270 days showing a deterioration mechanism 22 afterward until 920 days.

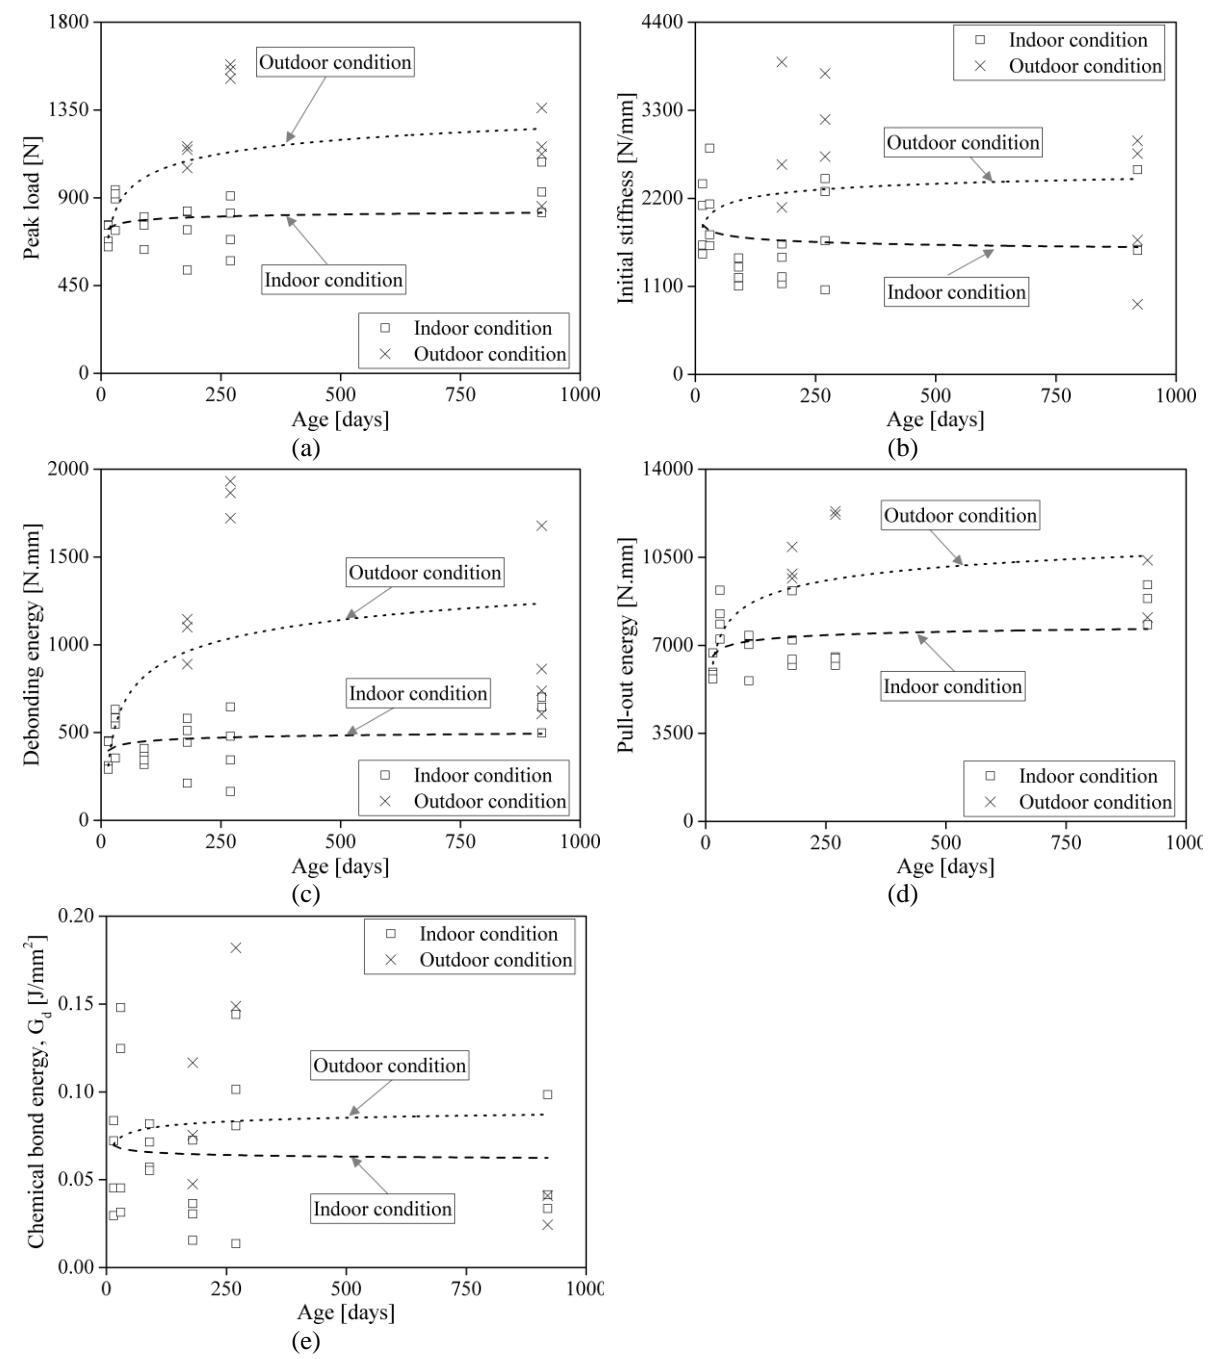
Fig. 8. Pull-out behavior parameters of the steel-based TRM: (a) peak load; (b) initial stiffness; (c) debonding energy; (d) pull-out energy; (e) chemical bond energy.

1 To better understand the role of environmental conditions, the changes in the key 2 characteristics of the pull-out curves with time is presented in Fig. 8. Here, the individual 3 sample results are all presented together with a nonlinear regression line showing the general 4 trend of the results with time. The mean values of pull-out parameters of indoor and outdoor 5 specimens are presented in Table A1 and Table A2 in the appendix section. It can be observed 6 that the peak load, the initial stiffness, the deboning energy, the chemical bond energy, and the pull-out energy show, in general, an incremental trend up until 270 days, and then the 7 8 values have decreased until the end of the tests in outdoor aged samples. Meanwhile, in indoor 9 aged samples, these properties reached their peak value at an early age and, after that, do not 10 show a significant change with time except for the chemical bond energy and initial stiffness, 11 which are slightly decreased in the initial stage of exposure. As expected, the variation of the 12 experimental results is also higher in the samples aged under outdoor conditions.

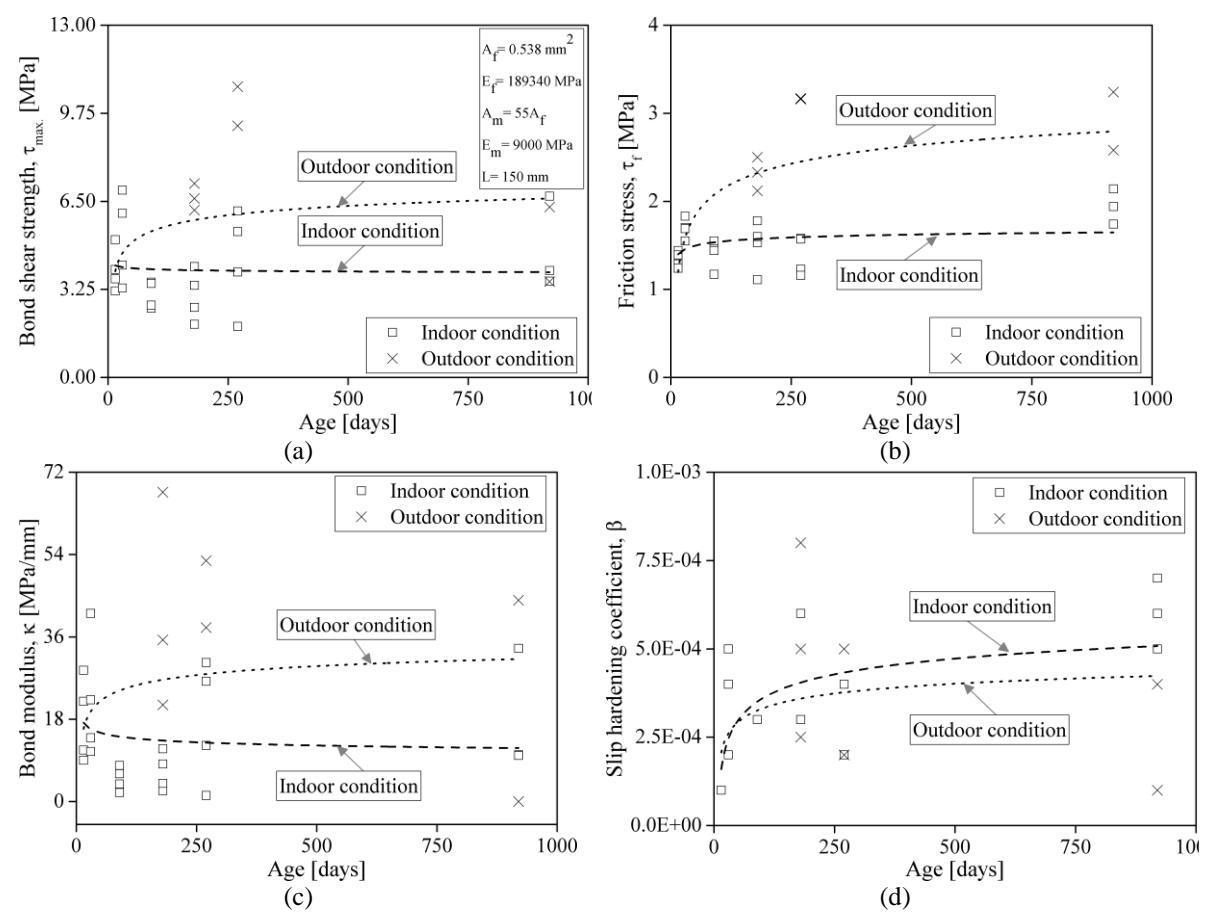
Fig. 9. Bond-slip law parameters of the steel-based TRM: (a) bond shear strength; (b) friction stress; (c) bond modulus; (d) slip hardening coefficient.

13 The average bond-slip laws are also presented in Fig. 9. Again, the bond strength, τ_{max} , (Fig. 14 9a), and the frictional strength, τ_f , (Fig. 9b) show an incremental trend in outdoor aged samples 15 (bond strength decreases from 270 days to 920 days), while no significant changes can be 16 observed in indoor aged samples. The bond modulus (κ), however, seems to be increasing 17 significantly in outdoor aged samples, but slightly decreasing in the early ages in indoor aged 18 samples (note a high variation is observed in the results for this parameter), Fig. 9c. At the 19 same time, the slip hardening coefficient (β) shows an increasing trend for both indoor and 20 outdoor aged samples (Fig. 9d); nevertheless, the indoor aged specimens show higher values 21 in contrast to the outdoor aged specimens. A comparison between τ_f and β shows the higher 22 frictional stress, the lower slip hardening coefficient. The mean values of the bond-slip laws

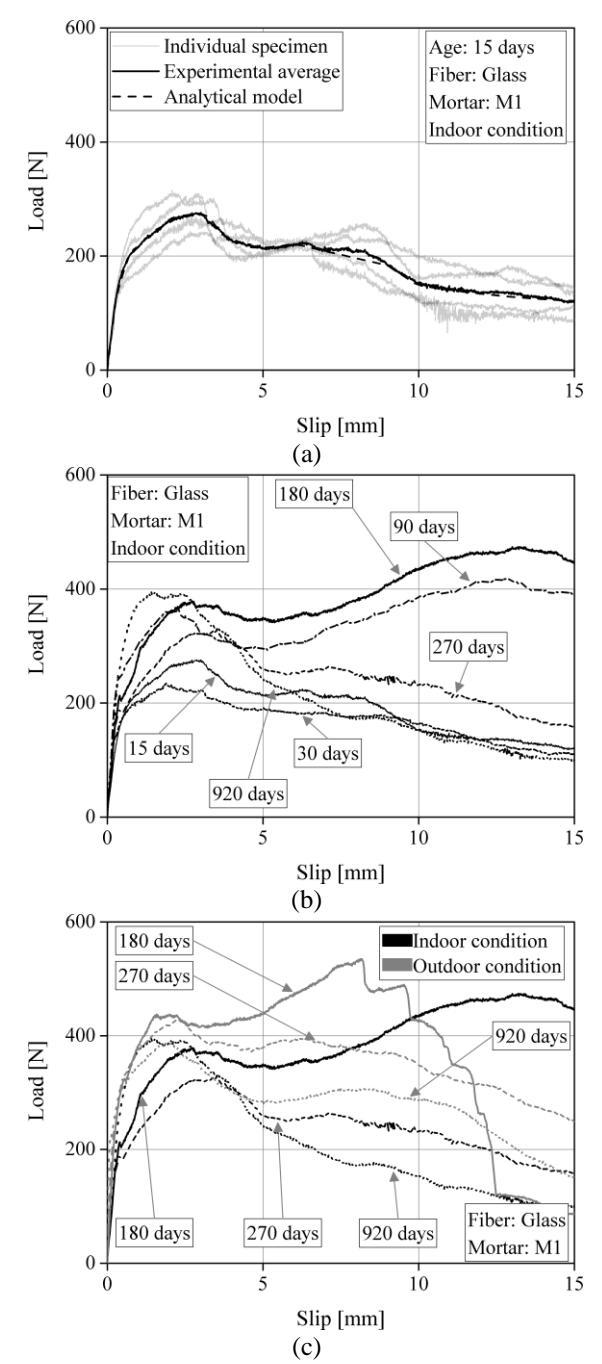
Fig. 10. Pull-out behavior of the glass-based TRM: (a) typical pull-out behavior; (b) effect of the mortar age; (c) effect of environmental conditions.

4 The pull-out curves of the individual samples, the experimental average, and the analytical 5 curves of the glass-based TRM are presented in Fig. 10. These specimens, in contrast to steel-6 based TRMs, do not show a sudden load drop after the peak load; thus, the transition from the 7 progressive debonding to the dynamic stage is smooth. This behavior can be due to the 8 insufficient curing condition of the M1 mortar, followed by the weak bond at the fiber-to-9 mortar interface. Comparing the pull-out curves tested at different ages and under indoor 10 conditions (Fig. 10b) shows that at early and late ages (until 30 days and after 270 days), the 11 slip hardening is followed by a softening in the pull-out curves. However, at 90 and 180 days, 12 the slip hardening is followed by a second slip hardening effect leading to significant 13 absorption of energy. This change of final slip softening at early ages to slip hardening seems 14 to be a result of further hydration of the mortar. Nevertheless, at later ages, it seems that a sort 15 of bond deterioration or mortar shrinkage by forming micro-cracks at the bond interface has 16 occurred, which led to a slip softening behavior.

17 Comparison of the indoor and outdoor aged samples indicates again that generally, outdoor 18 aged samples show a better bond performance compared to indoor aged samples, see Fig. 10c. 19 This behavior is in line with what is observed for the M1 mortar changes at indoor and outdoor 20 conditions. As also observed in indoor aged samples, a degradation of the bond performance 21 can also be observed in the samples aged under outdoor conditions at later ages.

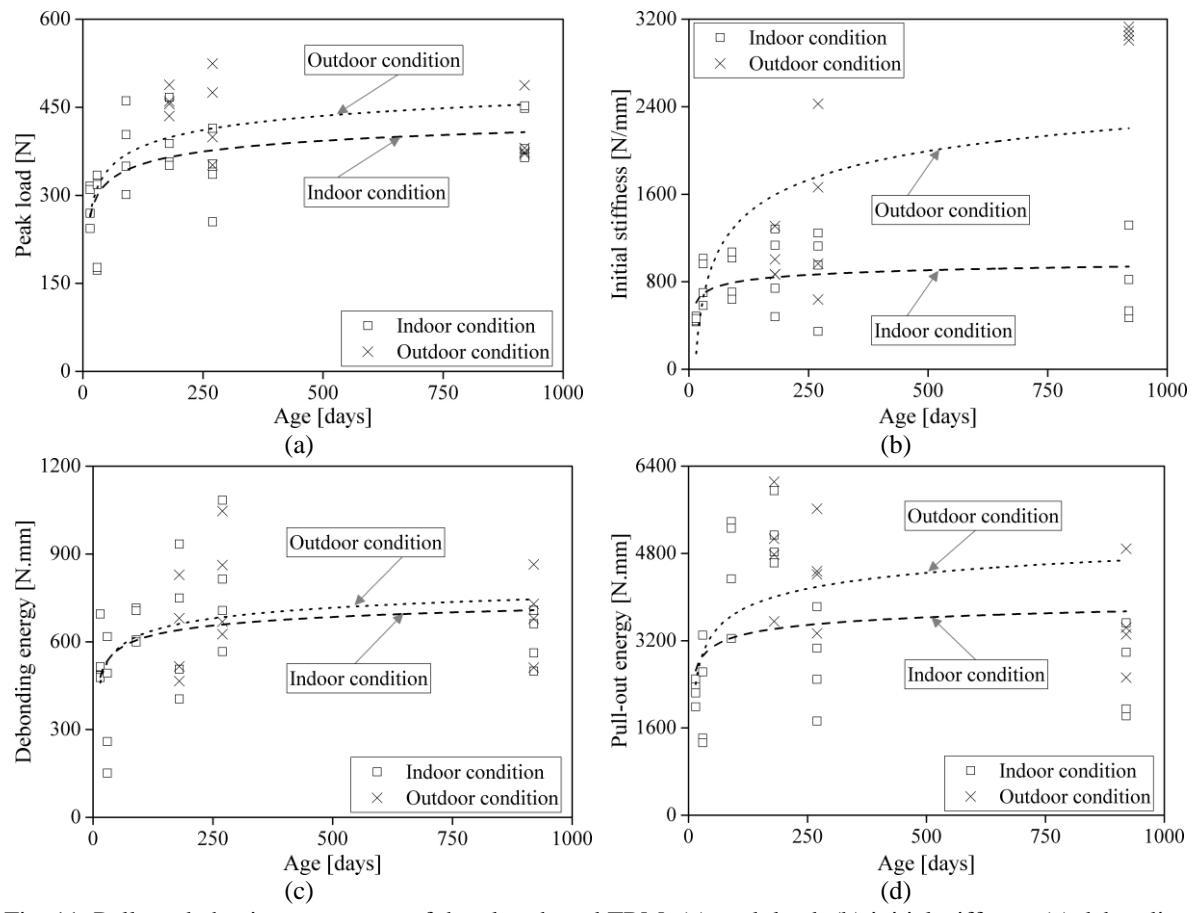
Fig. 11. Pull-out behavior parameters of the glass-based TRM: (a) peak load; (b) initial stiffness; (c) debonding energy; (d) pull-out energy.

1 specimens tested in the indoor condition. However, both the peak load and debonding energy 2 show a decline behavior from 270 days to 920 days in outdoor aged samples. The initial 3 stiffness of the outdoor aged samples is significantly higher than the indoor aged samples 4 becoming more than three times at 920 days, owing to better curing conditions or higher 5 hydration of the M1 mortar. Moreover, both the debonding energy and the pull-out energy 6 show an increase trend for indoor aged samples, energy desorption is always smaller than that of outdoor aged samples up until the end of the tests where they become close. Increasing the 7 8 energy desorption at the early ages of outdoor exposure can be due to improving the bond of 9 fiber-to-mortar. By increasing the exposure ages, the bond declined due to deterioration, 10 shrinkage, or micro-cracks. Again, the experimental mean values are presented in Table A5 11 and Table A6.

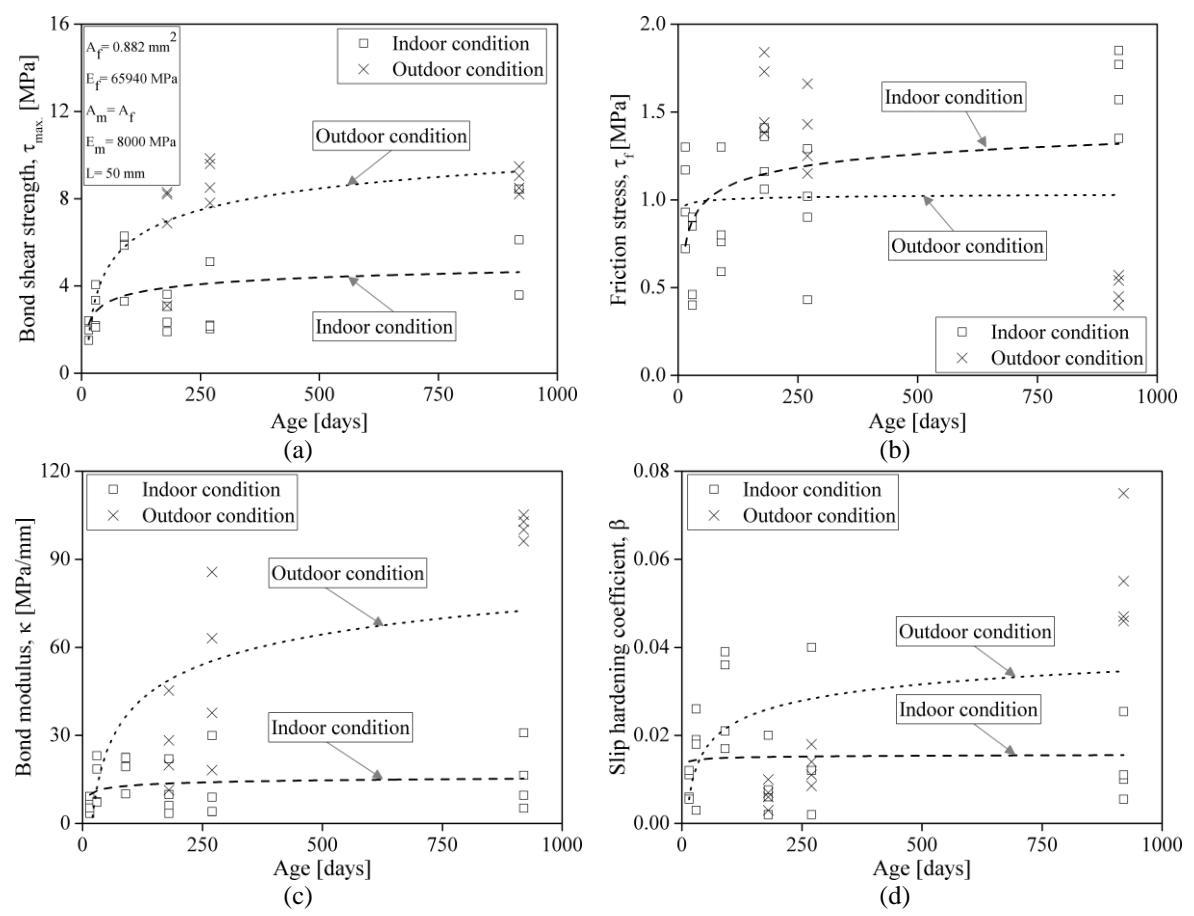
Fig. 12. Bond-slip law parameters of the glass-based TRM: (a) bond shear strength; (b) friction stress; (c) bond modulus; (d) slip hardening coefficient.

12 The changes in the bond-slip law parameters are shown in Fig. 12, Table A7, and Table A8. 13 The bond strength, τ_{max} , is always higher in outdoor aged samples than indoor samples (almost 14 twice at 920 days), as shown in Fig. 12a. On the other hand, the frictional stress, τ_f , shows an 15 incremental trend (initially with higher rates and then lower rates) in samples under indoor 16 conditions, in contrast to the outdoor aged samples in which a significant deterioration can be 17 observed from 270 to 920 days. By contrast, the bond modulus, κ , and slip hardening 18 coefficient, β , do not show a significant change in indoor aged samples but increase 19 significantly with time in outdoor aged samples. These observations can show the effect of 20 higher hydration of the M1 mortar on the parameters of the bond-slip law

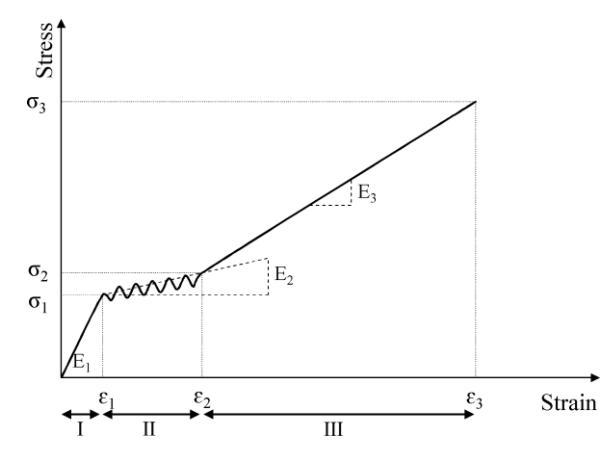
Fig. 13. Typical tensile stress-strain behavior of TRMs.

Fig. 13 shows the schematic tensile behavior of TRM composites [1,18,19,21,51–53], in which the tensile load was applied to TRM composites. While in this study, the load is applied 1 directly to the fiber meshes. Three stages are usually identified in the tensile response: (stage 2 I) a linear stage which presents the behavior of uncracked composite material [51–53]; (stage 3 II) a crack development stage in which multiple cracks are formed in the specimens. The 4 distance, the width, and the number of cracks are strictly dependent on the fiber-to-mortar 5 bond behavior in this stage [51–53]. Finally, (stage III), no further cracking occurs, and the 6 load is only resisted by the bundles/yarns. The peak tensile stress (σ), the strain corresponding 7 to the peak stress (ϵ) and tensile modulus (E) in each stage, and the saturated crack spacing 8 are the key characteristics of the tensile response of these composites and therefore will be 9 discussed in the next sections for each aging condition and TRM type.

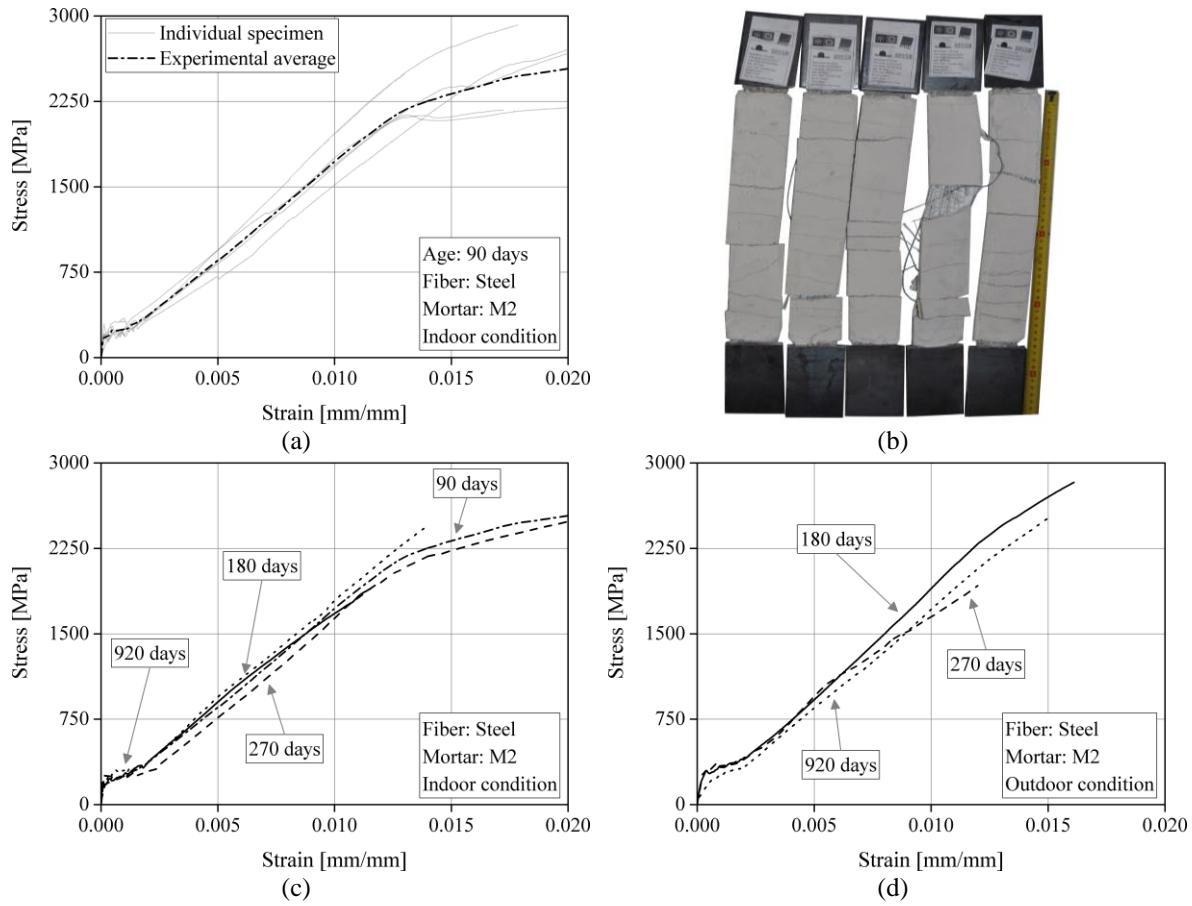
Fig. 14. Tensile response of the steel-based TRM: (a) typical tensile behavior; (b) saturated cracking stage at 90 days (indoor aged); (c) effect of the mortar age under indoor conditions; (d) effect of mortar age under outdoor conditions.

11 The typical tensile stress-strain response of individual steel-based TRMs at 90 days, together 12 with their experimental average curves, are presented in Fig. 14a. In all the specimens, fiber 13 rupture was the governing failure mode. In addition to the three typical stages of the tensile 14 response, explained previously, a final softening stage can be observed in the stress-strain 15 curves. This final softening is probably due to the non-uniform distribution of the stresses 16 among the cords or the step-by-step failure of wires. Cracking of the mortar can be clearly 17 observed in the samples Fig. 14b. Many cracks have formed, showing the balance between the 18 bond and mortar strength and suitable textile-to-mortar bond behavior in these samples.

At first glance, no significant change is observed in the tensile response of samples aged under indoor conditions, Fig. 14c, or the samples aged under outdoor conditions (despite the final tension strength), Fig. 14d, with time. However, looking at the changes in the main characteristics of the tensile response, Fig. 15, shows interesting trends. Only a slight increase can be observed in the first cracking stress, σ_1 , with time in indoor aged samples. However,

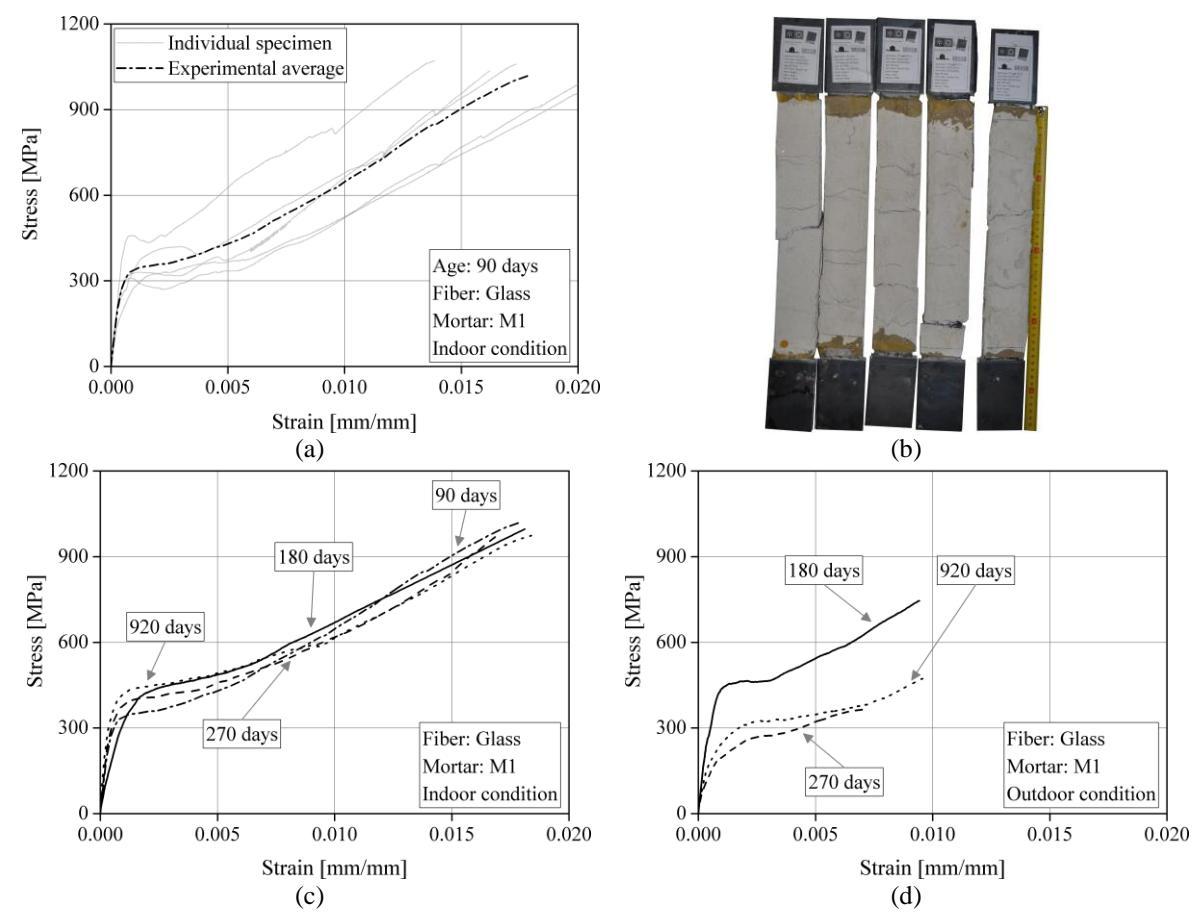
Fig. 17. Tensile response of the glass-based TRM: (a) typical tensile behavior; (b) saturated cracking stage at 90 days (indoor aged); (c) effect of the mortar age under indoor conditions; (d) effect of mortar age under outdoor conditions.

The typical tensile stress-strain response of individual glass-based TRMs (at 90 days), together with their experimental average curves, are presented in Fig. 17a. In all the specimens, again, fiber rupture was the governing failure mode. Although the three stages of the tensile response are identified in the curves, no fluctuation in the crack developing stage can be observed, which is due to the small number of cracks formed in these samples and/ or the low tensile strength of the glass fibers (Fig. 17b).

19 No significant change is observed in the tensile response of samples aged under indoor 20 conditions, Fig. 17c, though the samples aged under outdoor conditions, show the tensile 21 behavior declines by increasing the exposure, as presented in Fig. 17d. However, an in-depth 22 look at the changes in the main characteristics of the tensile response (Fig. 18) shows some 23 differences between the samples aged under indoor and outdoor conditions. As opposed to
