The condition, use and future of the UK's largest accessible dinosaur tracksite at Spyway Quarry, Dorset

Edgar, Kirsty; Meade, Luke; Jones, Harry ; Haller, Lewis; Scriven, Sam; Reedman, Christopher; Butler, Richard

DOI: 10.1016/j.pgeola.2023.01.001

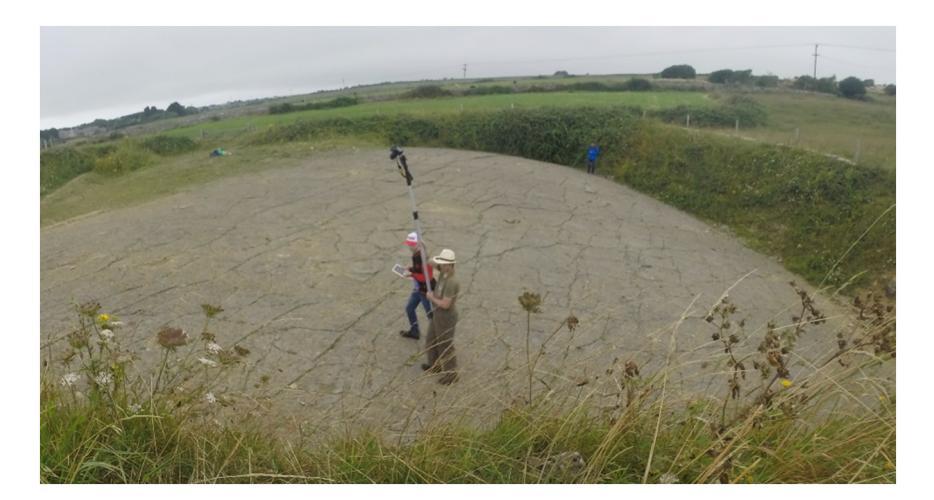
Fig. 2. Demonstration of the image capture system in action, used to take photos of the quarry surface for the 3D model by undergraduate researchers Harry Jones and Lewis Haller in August 2021 at Spyway Quarry. Photograph taken on a GoPro HERO3 + Silver Edition camera positioned above an exposed vertical quarry face in the east of the quarry.

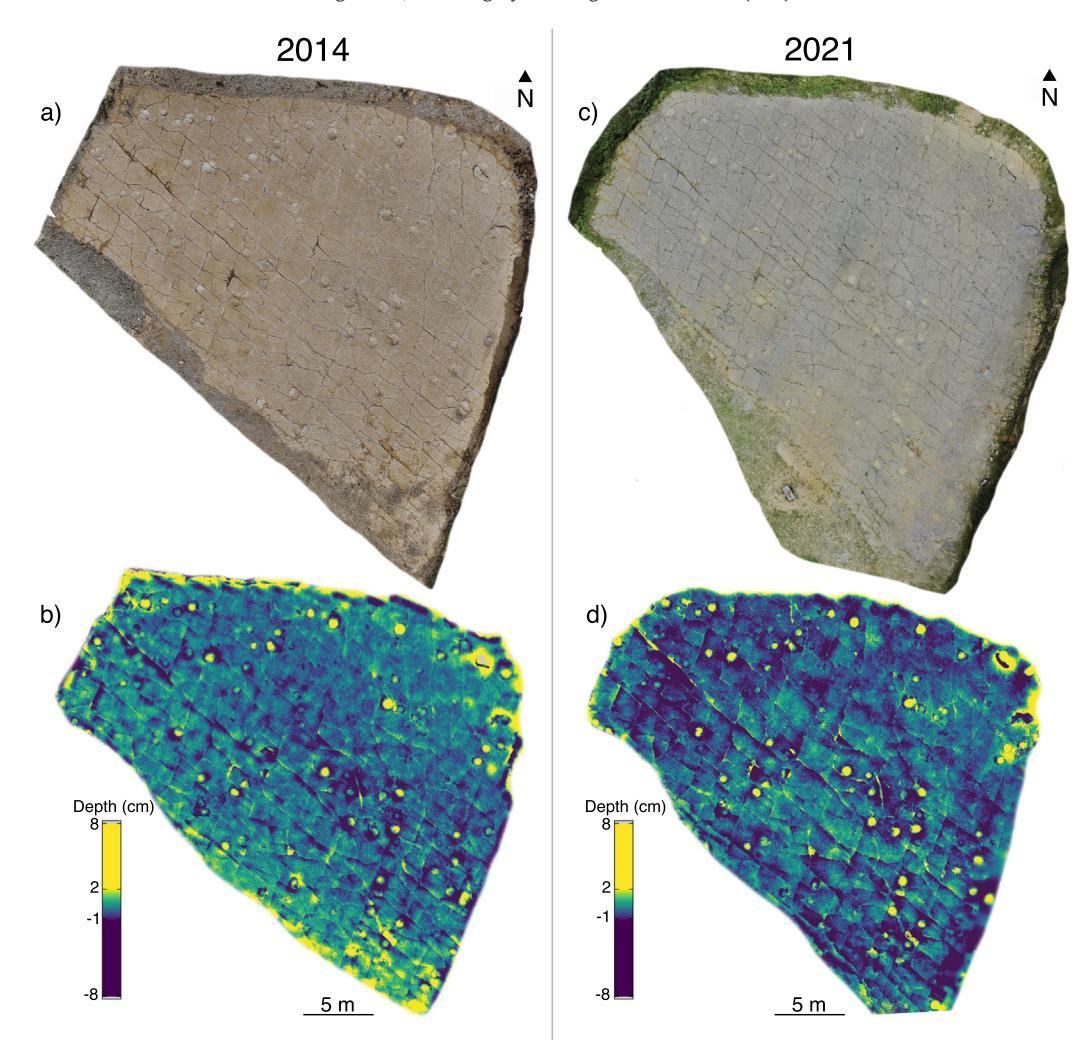
The number of recognised tracks has changed through time with numbers increasing based on newly exposed areas and/or closer inspection and decreasing as tracks become more indistinct (Figs. 3 and 4). 111 tracks were initially identified by Wright et al. (1998) on the quarry surface with a further three marked as indeterminate (numbered here as tracks 1–114 in Fig. 4). However, we note that Track 44 is missing from the originally figured line drawn map in Wright et al. (1998). We have not amended the numbering system to avoid confusion between different iterations. Based on the 2014 and 2021 photogrammetric models and field observations in 2021, a further 24 tracks were identified giving a total of 138 tracks at the site (tracks 115–138 in Fig. 4). These are predominantly located around the edges in the northern, northwestern, and eastern areas of the guarry where in 2014 there was a larger surface exposed than today or in 1998. Not all were still fully exposed in 2021 due to encroachment on the surface by vegetation and the embankments, e.g., tracks 90, 102, 120-123, and 133 (see Figs. 4 and 5). Also, a number of tracks that were identified in 1998 are no longer readily discernible on the surface in 2021 including tracks 55, 64, 67, 83, 93 and 94 with several others appearing very faint, e.g., tracks 7 and 8.

Fig. 3. Textured photogrammetric models of Spyway Quarry surface from 2014 (a) and 2021 (c). Height maps of flattened photogrammetric models of the Spyway Quarry surface from (b) 2014 and (d) 2021, detailing prominent tracks, cracks, and other reliefs. Minor colour differences generally reflect slight differences in flattening or photogrammetric model accuracy, rather than a change over time. Some detail around quarry edges has been lost during flattening. (For interpretation of the references to colour in this figure legend, the reader is referred to the web version of this article.)

Quantitative results were ground-truthed by examining a number of individual tracks on the quarry surface. Areas where material has been lost can easily be recognised because of the different colours of newly exposed and less weathered surfaces (Figs. 3 and 7) and closely match the damage map in Figure 6.

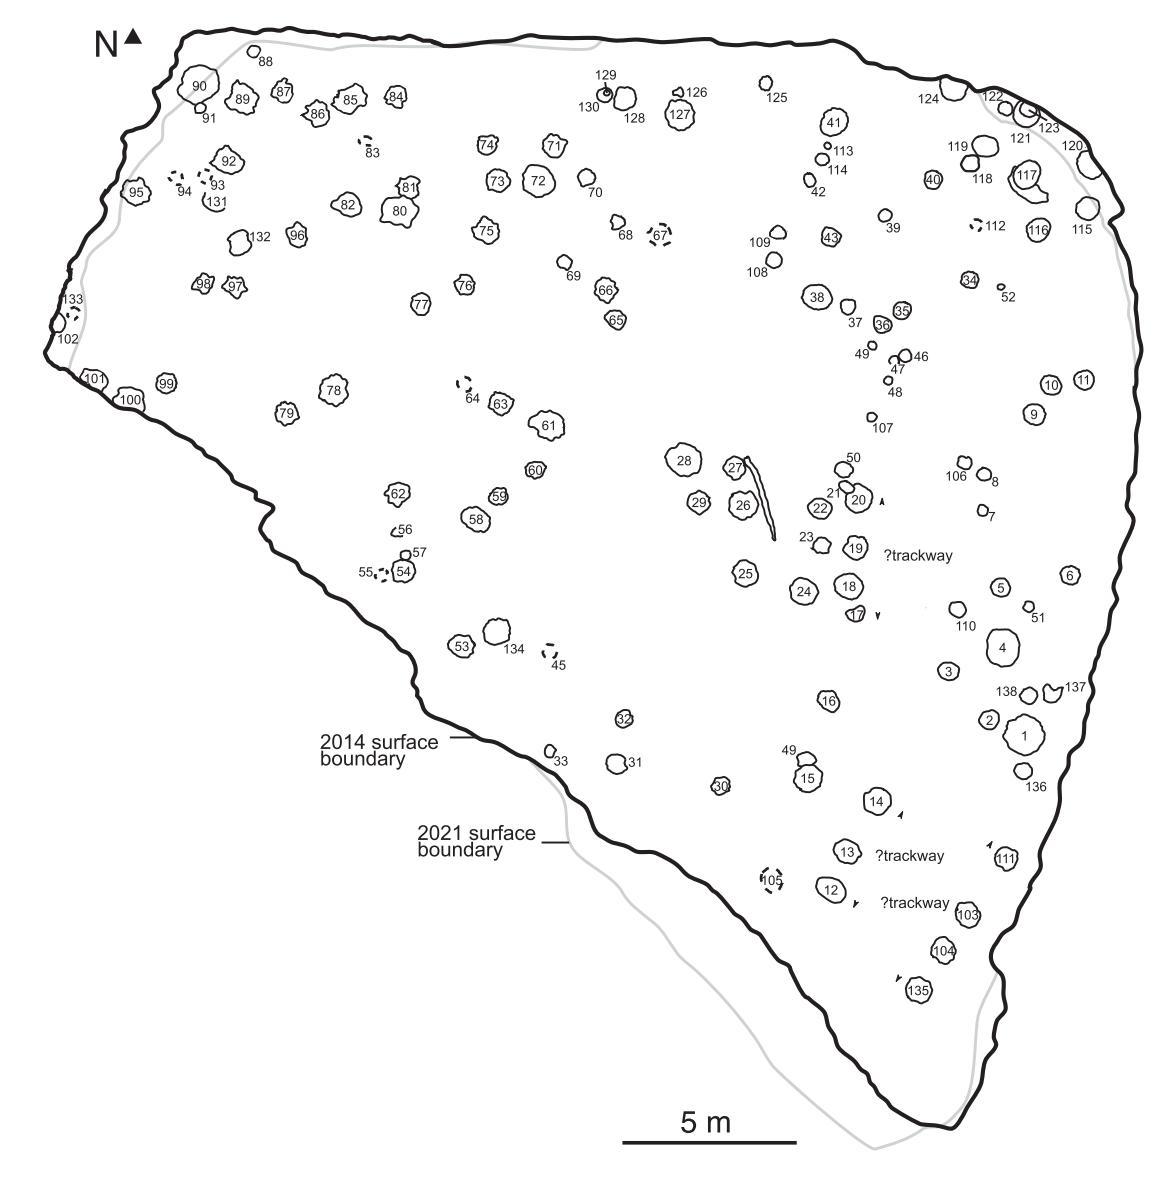
Fig. 4. Line map of identified tracks through time at Spyway Quarry (1998–2021). Track numbering follows Wright et al. (1998) for tracks 1–111; extended with newly identified tracks from photogrammetry and in the field in 2021 (tracks 115–138). Tracks that are poorly preserved or otherwise very indistinct/no longer visible are outlined with a dotted line. Changes to the extent of the quarry surface from 2014 to 2021 are shown by a fainter outline (the 2021 limit) in the NW, NE and S of the quarry outline. Three groups of tracks potentially representing trackways are identified between arrows on the map. Track 15a of Wright et al. (1998) is labelled as 49.

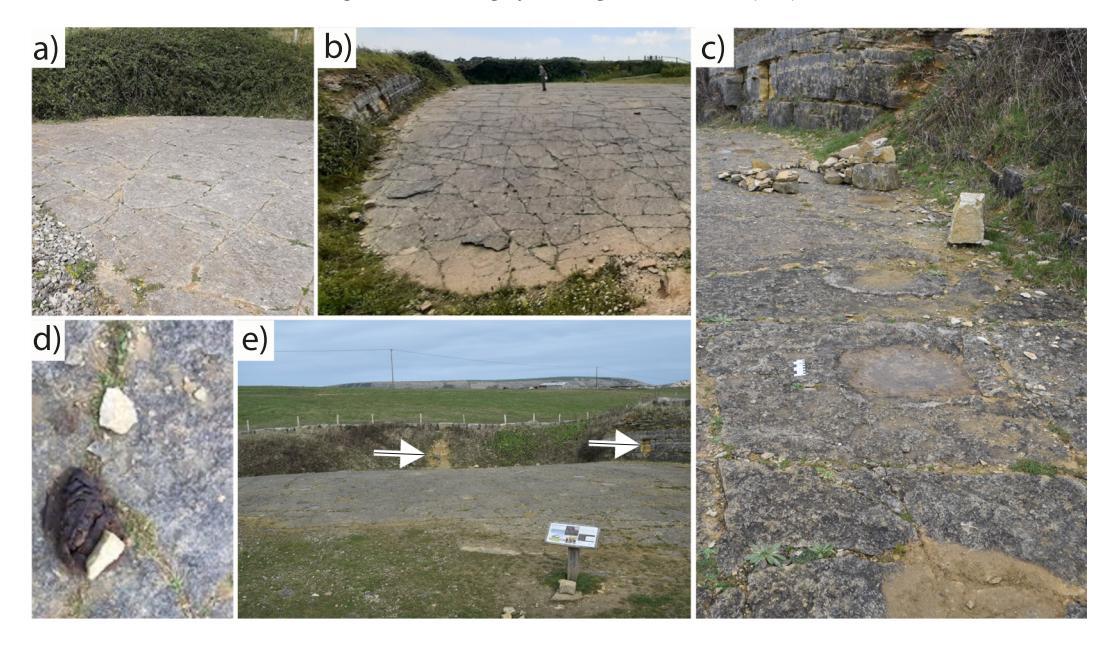
Fig. 5. Summary images showing a variety of hazards impacting the quarry surface. (a) and (b) Encroachment onto the quarry surface at the edges and loose blocks/gravel on the surface. (c) Tracks infilled with rainwater in the foreground, quarry fractures infilled with mud and vegetation, and in the background piles of large, jointed blocks that have come down from the edge of the quarry, *i.e.*, the layers above the surface are evident. Scale bar in (c) is 13 cm. (d) Cowpat on surface from when the gate to the quarry is left open and livestock can enter the site. (e) Arrow at northern quarry edge shows unstable margins and bank collapse on to the surface and in the east, a pronounced hole exposing a fresh surface where material has been weathered out.

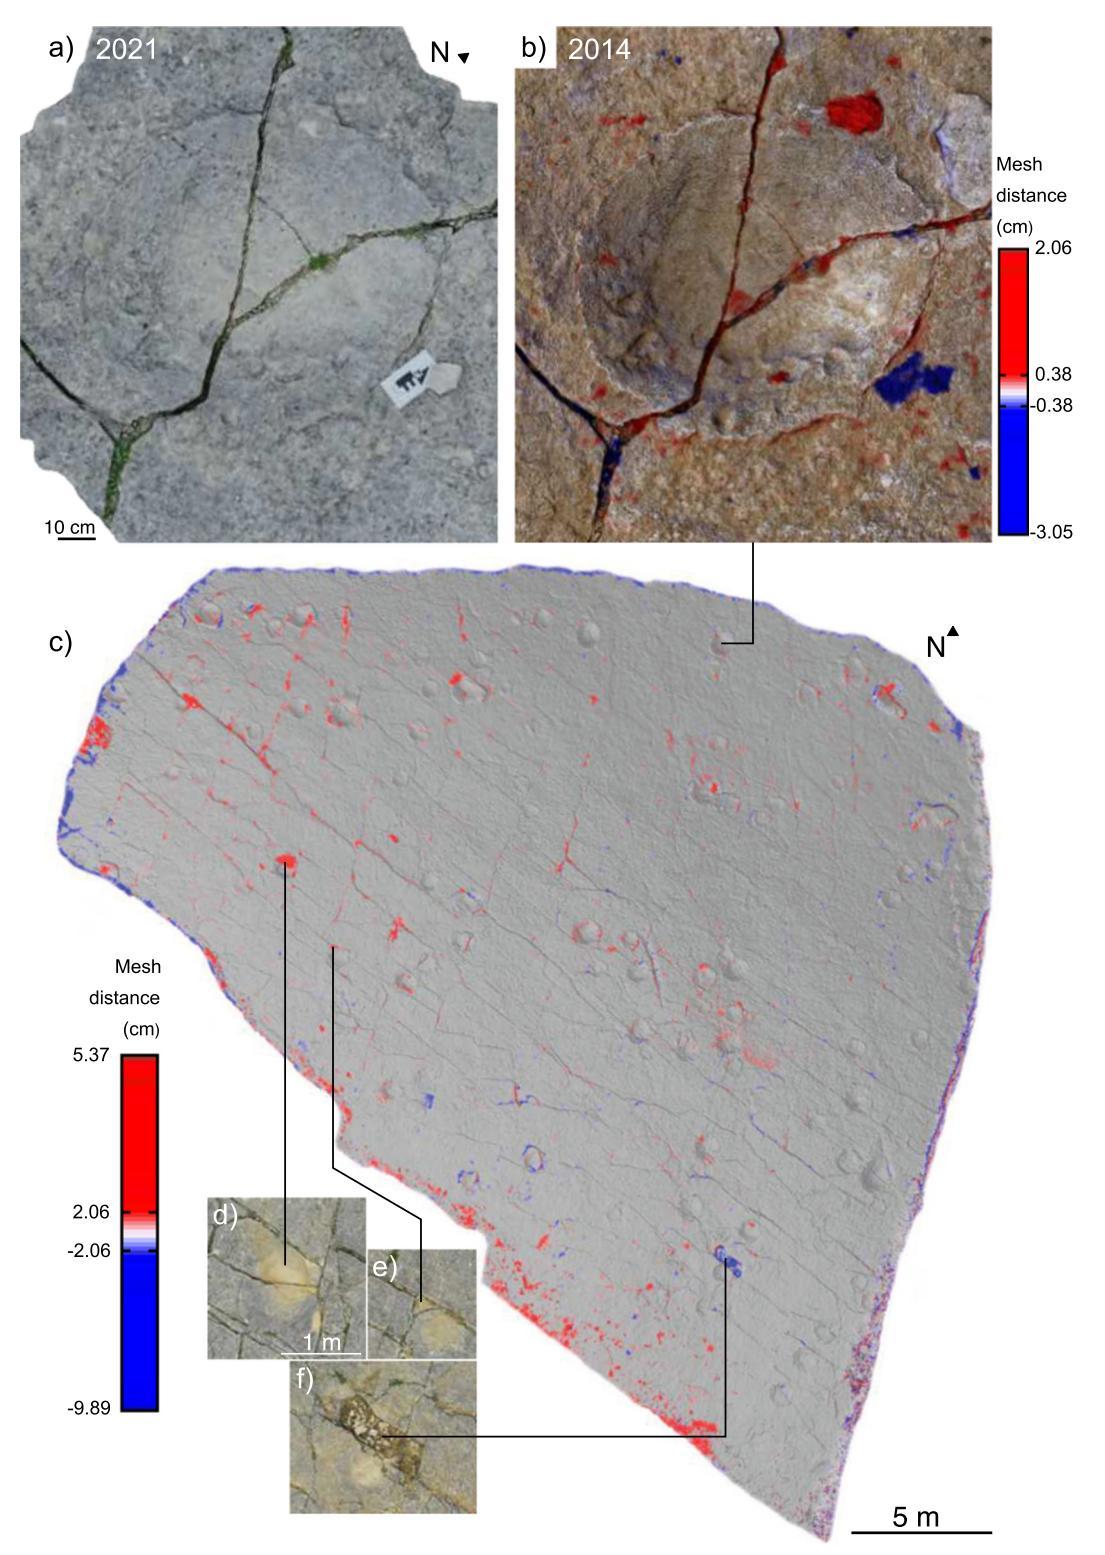
Comparison of the 2014 and 2021 3D photogrammetric models (Fig. 6) indicates changes of \pm ~20 mm are present across many areas of the surface. Loss of material (highlighted in red; Fig. 6) occurs primarily along fractures and within or along the rims of individual tracks, particularly at points where fractures and tracks intersect. This loss of material represents in some cases breakage/exfoliation of the surface – in other cases (such as the rims) it may represent more gradual weathering over time. These changes are pronounced given that tracks have an average depth of ~10–45 mm with the rim having a maximum depth of ~25 mm (Wright et al., 1998). Gain of material (highlighted in

blue; Fig. 6) generally represents the accumulation of loose material on the surface or within fractures. The edges of the quarry surface generally show additions or loss of material between the two models but these are disregarded here due to these areas being more likely to contain artefacts in the photogrammetric models and the generally higher and more variable levels of foliage and debris, including loose material cleared from the tracks prior to imaging as detailed in Methods.

Damage occurs to tracks across the entire surface (Fig. 6), not just in those areas that are most frequently visited by the public (Fig. 9) and not just in the areas of highest fracture intensity. Whilst our data and observations suggest that the former may be a contributing factor, we

Fig. 6. Comparison maps showing damage and loss of material at Spyway Quarry based on the mesh distance between photogrammetric models of Spyway Quarry from 2014 and 2021. (a) and (b) show photogrammetric models of Track 41 from 2021 (a) and 2014 (b); the 2014 model (b) has red colouration highlighting areas now missing in 2021 (a), blue colouration indicates areas where material has been added (*i.e.*, scale bar, loose material, plant growth). A photogrammetric model from 2014 of the whole quarry surface is shown in (c); red coloured areas indicate material has been lost 2014–2021, primarily due to fracturing and these fragments being lost/moved; blue indicates material gained 2014–2021, primarily due to fracturing and these quarry surface in (c). (d) Track 78 showing loss of half of the track surface. (e) Track 62 showing damage around the edge of the track. (f) Large surface depression above Track 13 filled with mud and loose material from quarry surface and margins. To best see the differences in the surface please see the colour version of this article online. (For interpretation of the references to colour in this figure legend, the reader is referred to the web version of this article.)

material along fractures in the surface, which is likely to exacerbate weathering processes (*e.g.*, Fig. 6). This is currently managed by the National Trust *via* annual spraying of the surface with herbicide. Second, the potential access of livestock to the site if visitors leave the gate open (Supp. Fig. 2). It is unclear how frequently this may occur. The gate does have a spring to help it close but the latch requires the gate to be firmly pulled shut on entry/exit to be engaged properly. Finally, by leaving the overlying layers exposed above the track surface (~2 m high), the heavy fracturing of the beds means that large blocks can fall out (*e.g.*, pile of blocks at quarry edge in Fig. 5c). This could damage the surface with blocks impacting and then being moved around the surface and could be a hazard for visitors themselves who frequently sit underneath the quarry wall.

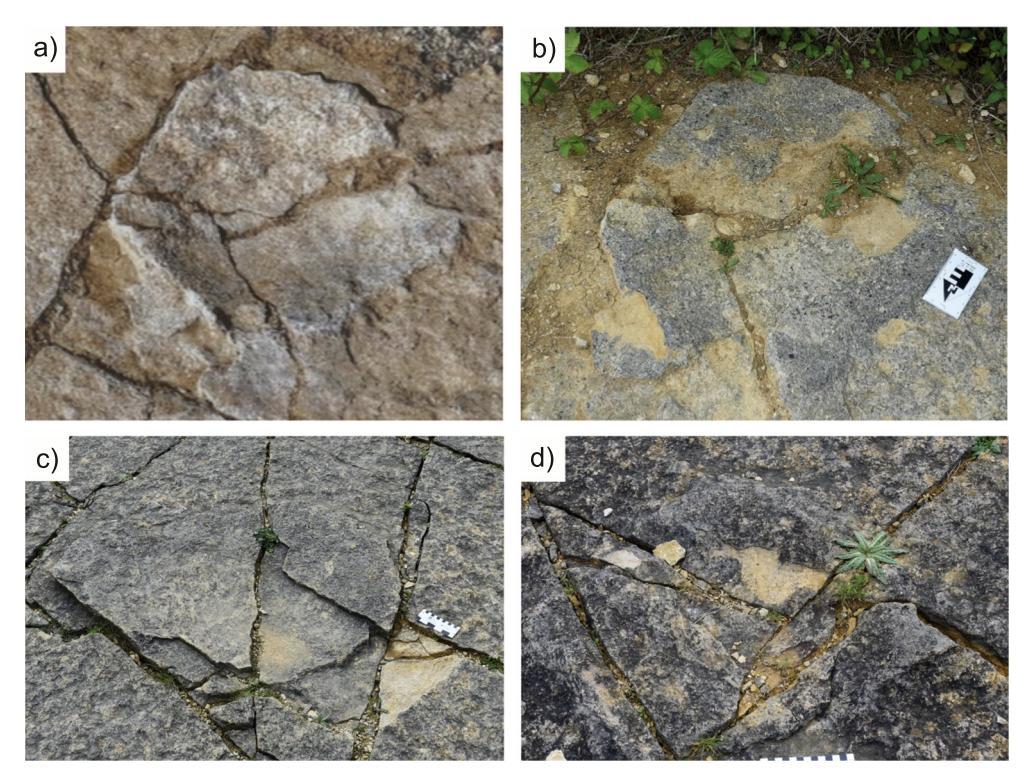
Fig. 7. Summary photos showing different kinds of preservation and damage in Spyway Quarry. (a) and (b) show Track 95 in 2021 and 2014, respectively. Note the widening of the fractures, loss of definition from the track edge and missing material shown by exposed yellow/brown fresh rock surface. (c) In 2021, a large section lifted at intersection of two large fractures and (d) Track 98 in 2021 with material coming from the track surface itself originating from the fracture. Scale bar in (c) and (d) is 13 cm. (For interpretation of the references to colour in this figure legend, the reader is referred to the web version of this article.)

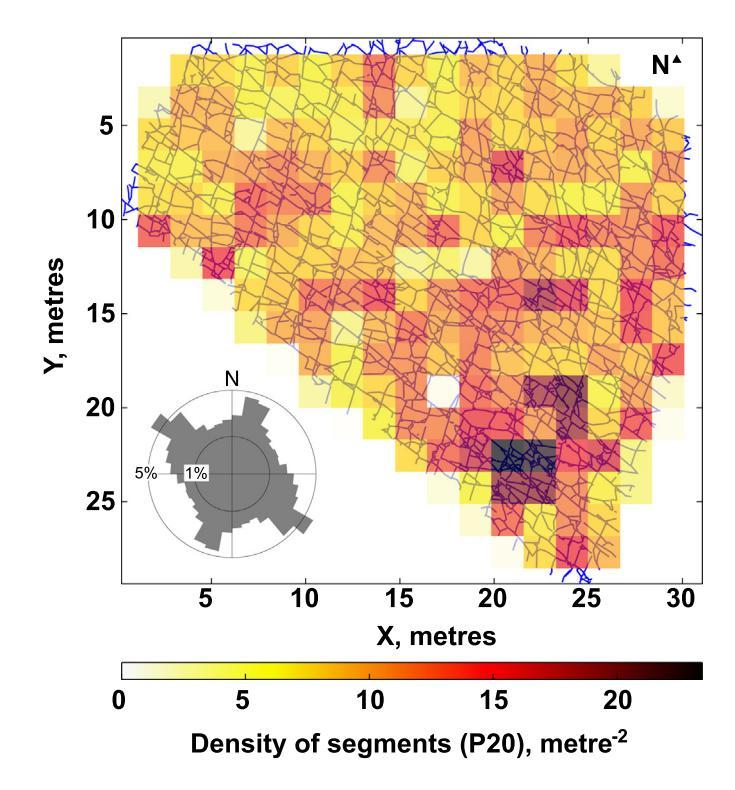
The quarry surface is extensively fractured with >3 fractures/m² across the majority of the quarry surface (Fig. 8). The most intense fracturing is in the southernmost part of the quarry reaching > 20 fractures/ m^2 within two grid cells (see darker colours in Fig. 8). There are two dominant fracture directions nearly perpendicular to one another running ~NNE–SSW and SE–NW, with smaller and less extensive fractures distributed relatively consistently across the surface in all directions.

Fractures are commonly infilled with small loose pieces of rock that have broken away from the surface elsewhere and/or vegetation. Most individual tracks are intersected by one or more fractures.

Fig. 8. Heat map showing relative density and distribution of fractures (units of length⁻²) on the surface of Spyway Quarry. The vector lines representing identified fractures from the 2014 photogrammetric model underlay the density heat map. Bottom left-hand corner is a rose diagram plotted using area-weighting, presenting the distribution of fracture orientations in relation to North. Mapped traces (n = 2232), segments (n = 5405) and nodes (n = 7637). (For interpretation of the references to colour in this figure legend, the reader is referred to the web version of this article.)

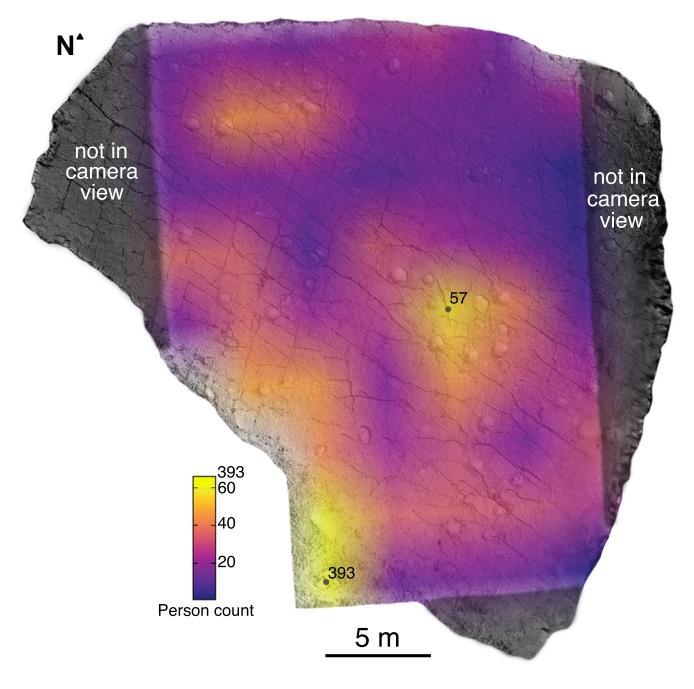
We recorded 1703 non-unique visitor occurrences on the visible areas of the guarry surface across the sample interval, *i.e.*, each visitor may be counted multiple times if they appear in multiple photographs (Supp. Table 1). The most highly visited single spot in the quarry was the information board with 393 recorded occurrences (Fig. 9). Other occurrence 'hotspots' are present on the quarry surface in the area along the southwest edge of the quarry surface, near the visitor information board, and then associated with two clusters of distinctive tracks immediately in front of the visitor information board (reaching the highest number of occurrences at Track 57, adjacent to a long groove on the surface that has been interpreted as a foot drag mark: Wright et al., 1998) and then another cluster towards the northern edge of the quarry, again associated with a relatively obvious cluster of tracks. Note that the far western and eastern edges of the quarry are not included in our analysis because they were not visible in the photo dataset, although qualitative observation of visitors suggests that they commonly spend time immediately next to the quarry wall on the eastern edge of the site.

Fig. 9. Colour gradient map detailing areas (binned into approximately 3 m² grid squares) of the quarry surface most frequently occupied by people in periodically taken photographs. Warmer colours (lighter grey–white in print version) indicate areas more frequently visited/where people stay for longer. The location of the highest recorded people count on the quarry surface and overall highest value are marked on the map (57 on the quarry; 393 at information board). Colour scale linear from 0 to 60, then identical from 60 to 393. (For interpretation of the references to colour in this figure legend, the reader is referred to the web version of this article.)

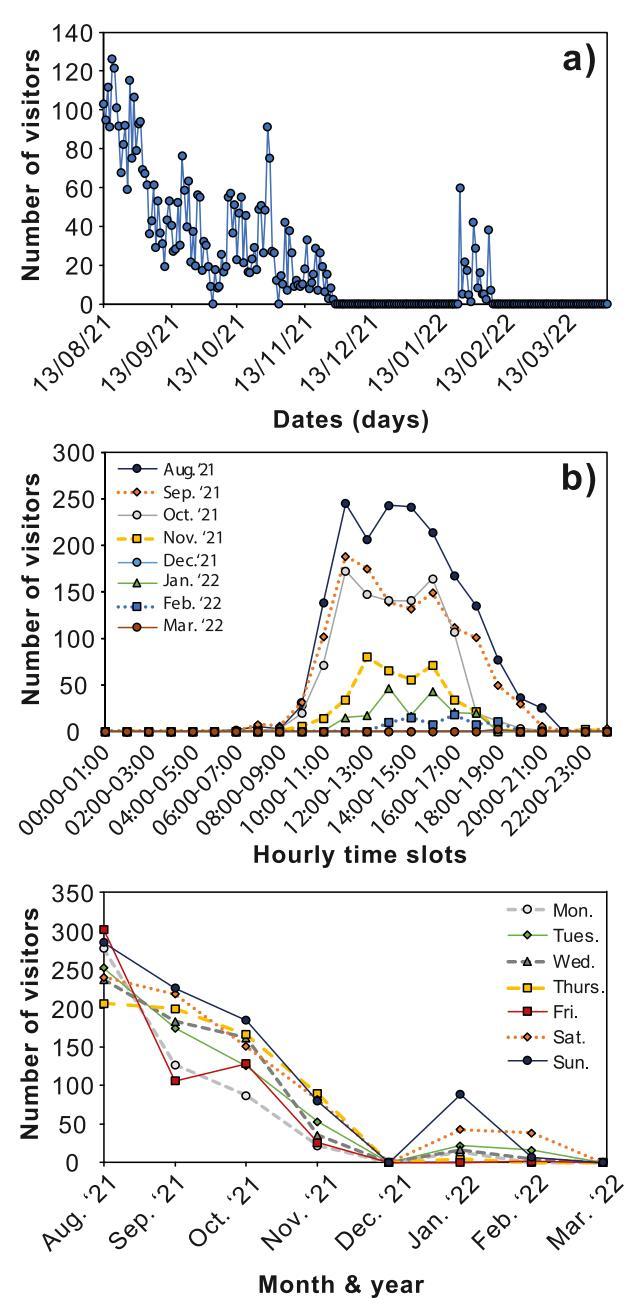
Visitor numbers as recorded by the counter were highest in August 2021, with 1802 visitors recorded over the 19 days from first installation of the counter, then declined through September and October (Fig. 10a; Supp. Table 2). As noted above, absolute values for data from November to March are considered incomplete due to the sensor having been dislodged. August therefore saw the highest number of weekly visitors, exceeding 600 per week during the final two weeks of the month. Visitor numbers were typically around 250-300 per week in September and October, although with some weeks dropping below 200 visitors. Maximum visitors on any single day were around 120 in August 2022. Visiting hours unsurprisingly correlate with daylight hours, with first visitors tending to arrive within a couple of hours after sunrise and the last visitors within 1-2 h after sunset, meaning visiting hours extended for longest during the summer months and declined into the autumn and winter (Fig. 10b). The daily visitor numbers show some signs of positive skew, with relatively few visitors early in the day, a peak around late morning to midday, and then a gradual reduction in visitor numbers through the afternoon and early evening. In some months a second, or even higher, peak is present in the mid-afternoon. There is no consistent pattern in the data of weekends being busier than weekdays for visitors between months (Fig. 10c). However, in terms of total visitors per day over the course of the study interval, Spyway Quarry receives the most visitors on Saturdays and Sundays.

Fig. 10. Summary of visitor data from 13th August 2021 to 31st March 2022 based on the counter installed at Spyway Quarry. a) Number of visitors across the entire study interval. b) Total number of visitors in each one-hour time window for each month. c) Total number of visitors per day in each month. Note that data from 26th November to 31st March is considered suspect because of sensor misalignment.
