A matched irrigation and obturation strategy for root canal therapy

In root canal therapy, irrigating solutions are employed to eliminate the bacterial load and also prepare dentin for sealer interaction. The aim of this research was to assess how irrigating solutions employed on their own or in sequence affected the tooth structure. The best way to prepare the tooth for obturation using hydraulic calcium silicate cement (HCSC) sealers and gutta-percha, thus guiding clinicians on a matched irrigation-obturation strategy for optimized root canal treatment was investigated. The effect of irrigating solutions on dentine was investigated by assessing changes in dentin microhardness, ultrastructure and mineral content, organic/inorganic matter, surface roughness and Young's modulus. The interaction of four root canal sealers with the dentin was analysed by assessing the changes in microhardness of the dentin after sealer placement and also the sealer to dentin interface by scanning electron and confocal laser microscopy. The irrigating solutions damaged the dentin irreversibly both when used on their own and in combination. The best sequence involved sodium hypochlorite followed by che

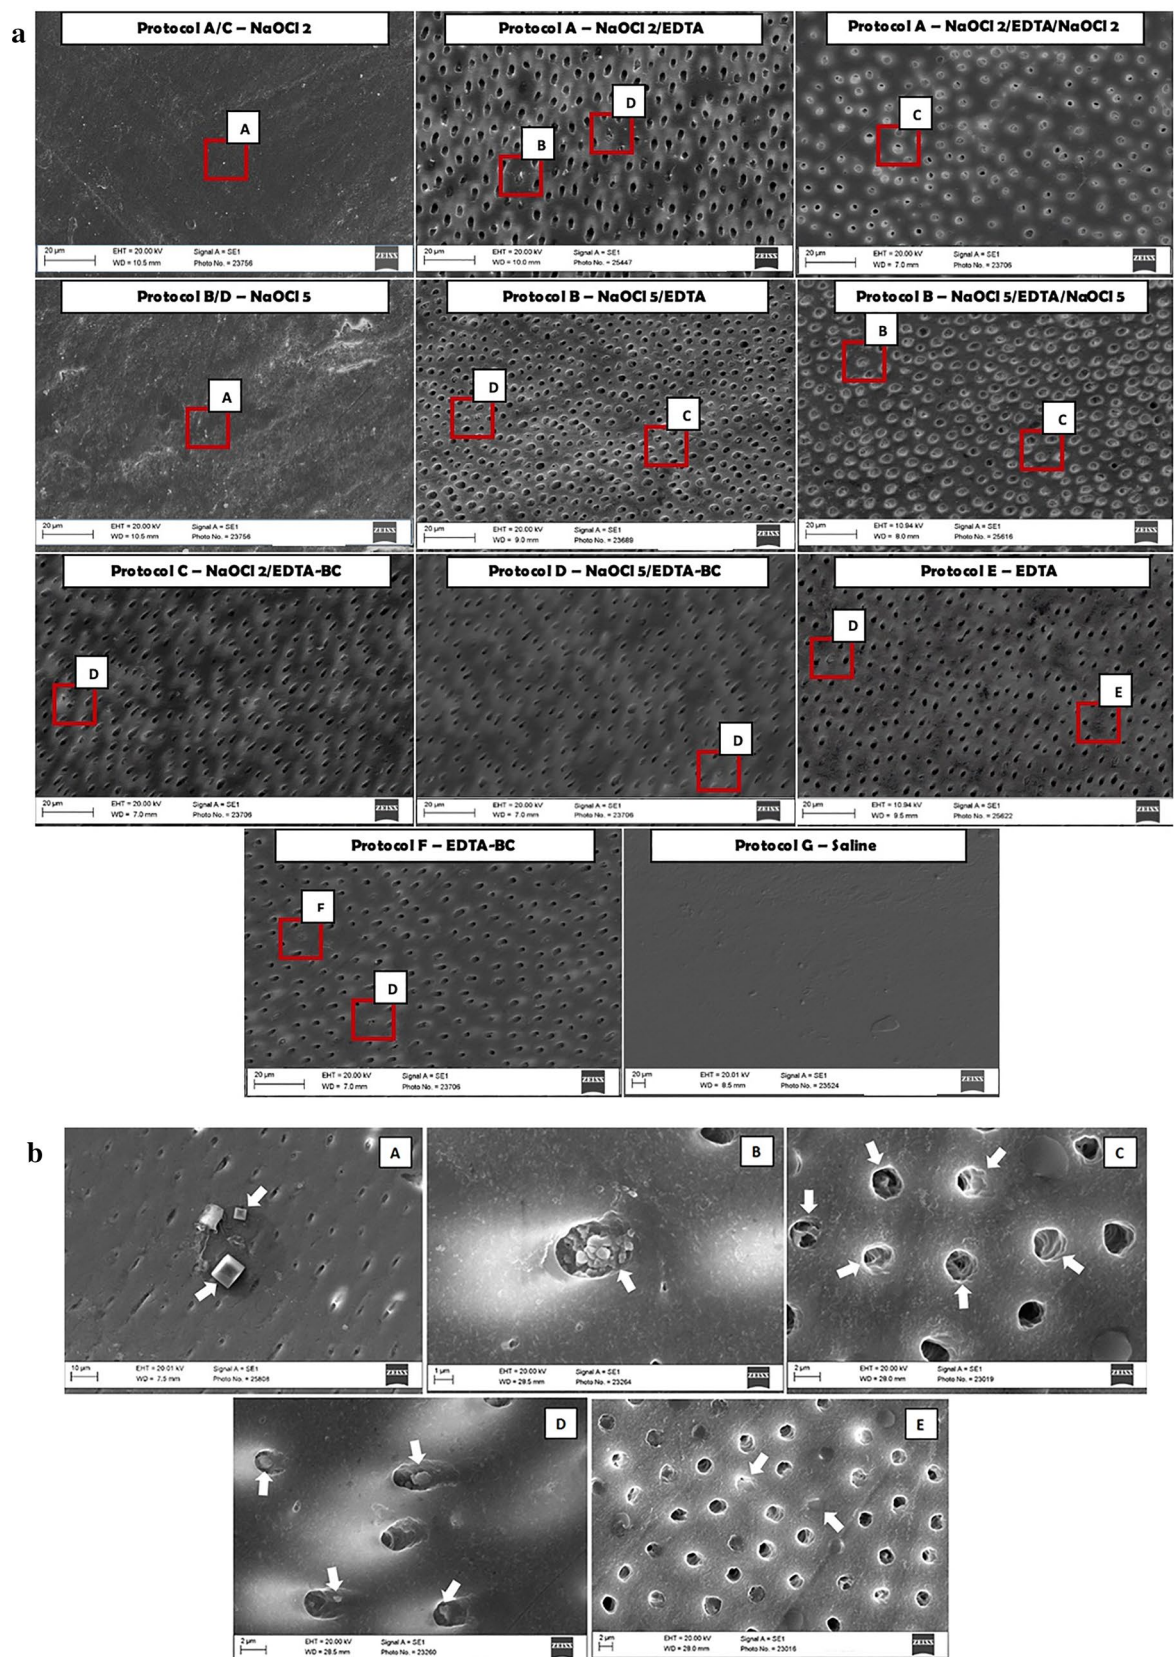
Figure 1. (a) Representative images of root dentin at $\times 2$ K magnification after the different irrigation protocols on the surface. The letters on the images indicate the areas that were viewed at higher magnification and are shown in (b). (b) High magnification scanning electron micrographs (3 K \times : A,C,E; 4 K \times : B,D); of the areas marked by the letters A–E in Figure (a). The areas are indicated with white arrows. (A,B) shows the presence of cuboid crystals rich in sodium and chlorine on dentin and inside dentinal tubules, respectively; (C) shows the peritubular and intertubular dentinal erosion; (D) shows the presence of smear layer inside dentinal tubules and (E) shows the sclerosis of dentinal tubules.

Morphology and composition of dentin. Scanning electron microscopy (SEM) and energy dispersive spectroscopy (EDS). The scanning electron micrographs of the dentin treated with different irrigation protocols are shown in Fig. 1a and higher power images of specific areas are shown in Fig. 1b. Both concentrations of NaOCl failed to remove the smear layer as is indicated in Protocols A and B, when the NaOCl was used as the first irrigant. Small deposits were observed on the dentin surface (marked A in Fig. 1a). High magnification of these deposits (Fig. 1b) revealed the cuboid shape of the crystals which is typical of sodium chloride¹⁶. This was confirmed by EDS analysis. For both Protocol A and B, the use of EDTA after the NaOCl, led to the widening of the dentinal tubules which was more effective in the 2% sodium hypochlorite group (Fig. 1a). After EDTA irrigation some crystals of sodium chloride were visible inside the tubules (area marked as B in Fig. 1a) in certain areas shown in high magnification in Fig. 1b. A final rinse with sodium hypochlorite resulted in the erosion of the dentin around the tubules (Fig. 1a area marked as C).

The use of EDTA–BC after the NaOCl as in Protocols C and D resulted in widening of the dentinal tubules with some erosion. The dentinal tubules were less evident than when using EDTA after the hypochlorite as in Protocols A and B. After the use of chelators small amounts of smear layer were present inside dentinal tubules for Protocols A, B, C and D (Area marked as D in Fig. 1a shown in high magnification in Fig. 1b), which disappeared after the final flush of sodium hypochlorite. The use of EDTA and EDTA–BC as sole irrigating solutions in protocols E and F showed widening of the dentinal tubules also with some sclerosis (Fig. 1a area marked E) at the periphery and presence of smear layer. Saline used on its own as in Protocol G did not have any effect on the smear layer removal.

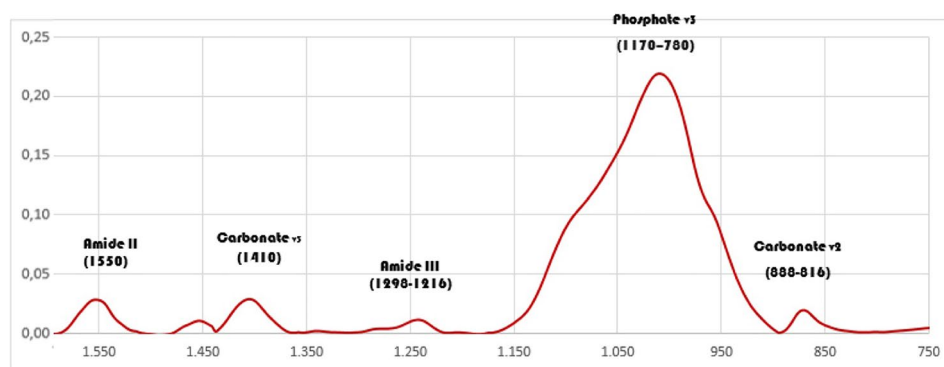
Figure 2. Representative infrared spectral region between 1600 and 750 cm^{-1} of untreated dentin showing the absorption peaks of the main dentin components.

Fourier transform infrared spectroscopy (FT-IR). The infrared spectral region between wavenumbers 1600 and 750 cm^{-1} of untreated dentin is shown in Fig. 2 indicating the absorption peaks amide III (1298–1216 cm^{-1}), phosphate (1170–780 cm^{-1}) and carbonate (888–816 cm^{-1}). Table 2 shows values for the ratios of amide III/phosphate and phosphate/carbonate respectively, on the dentin surface before and after immersion in the irrigants contained in the Protocols A–G. NaOCl first (G1 and G4) and final flush (G3 and G6) caused a decrease on organic matter by the deproteinization of collagen on dentin that is recovered by the follow use of chelators, although these changes were not sufficient to alter significantly the amide III/phosphate ratio (Protocols A–G2, B–G5 and C–G7; Table 2). When NaOCl was followed by EDTA–BC (Protocol D–G8) the collagen ratio increased significantly ($p = 0.004$). The previous use of the higher concentrated NaOCl (Protocol B–G4) seems to stimulate the demineralization of dentin by EDTA ($p = 0.015$; Table 2; G5) in comparison to 2% NaOCl ($p > 0.05$; Protocol A–G2).

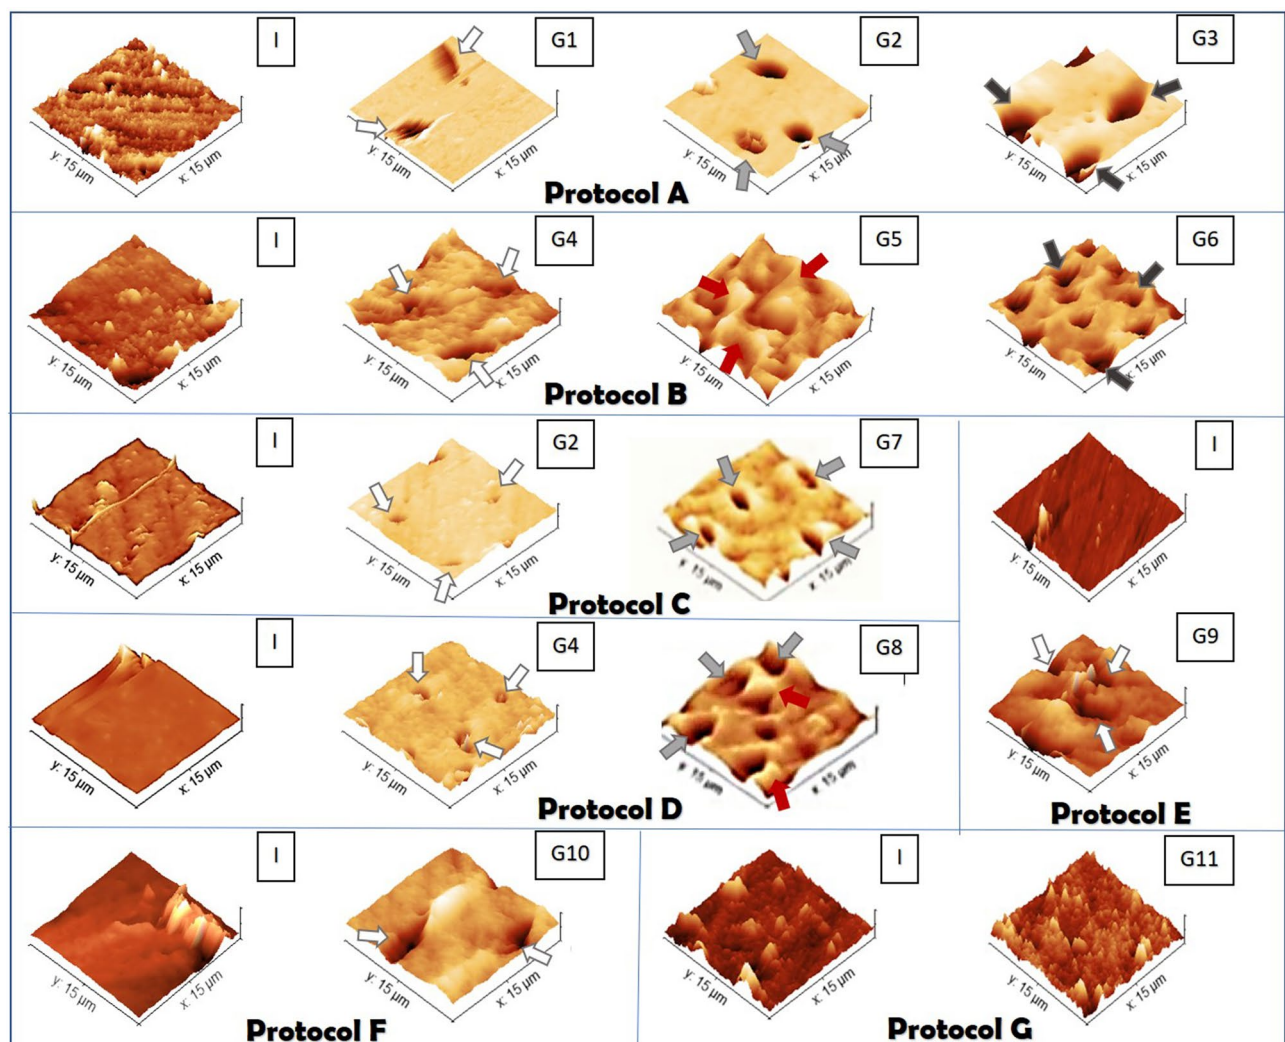
Figure 3. Atomic force micrographs showing topography of the dentin surface before (initial—I) and after immersion in the irrigation solutions (G1–G11; horizontal axis) as indicated in Protocols A–G detailed in Table 1. White arrows indicate less evident dentinal tubules in groups with NaOCl or chelator single flush. Light grey and dark grey arrows expressed a wider range and progressive widening of the dentinal tubules when both irrigants were used in a Protocol alone or adding NaOCl as a final flush, respectively. In protocol NaOCl+ chelator, (5%) NaOCl promoted a rough surface of dentin indicated by red arrows.

Atomic force microscopy (AFM) analysis. The Young's modulus data is shown in Table 2 and representative AFM images (Fig. 3) show the changes to the dentin samples subjected to the irrigation protocols. Based on Table 2, it is clear that the Young's modulus of the dentin was altered by NaOCl used as the first irrigating solution (G1 and G3), chelators such as EDTA (G9) used on its own and saline (G11). When combined in a protocol, the proteolytic effect of NaOCl on dentin collagen followed by the chelator demineralization effect on dentin caused a progressive decrease in dentin Young's Modulus (Protocols A–G2, B–G5 and D–G8; $p < 0.001$). Interestingly, NaOCl final flush increased these values (Protocols A–G3 and B–G6; $p < 0.001$), to the original levels ($p > 0.05$). The AFM images (Fig. 3) show the smear layer that totally covered the dentin in the initial step. The attenuation on image colors after the first application of NaOCl on dentin is related to a decrease of smear layer height on its topography. When the chelators were used alone as in Protocols E–G9 and F–G10, only a limited number of dentinal tubules could be observed. The irrigation protocols that included both the NaOCl and the EDTA resulted in a wider range of open dentinal tubules (G2 and G5; marked with light grey arrow), whereas the 5% NaOCl promoted a rougher dentin surface compared to the 2% concentration (marked with red arrow). A smoother surface and widening of the dentinal tubules (dark grey arrows) was observed after the final step of irrigating with NaOCl in Protocols A–G3 and B–G6.

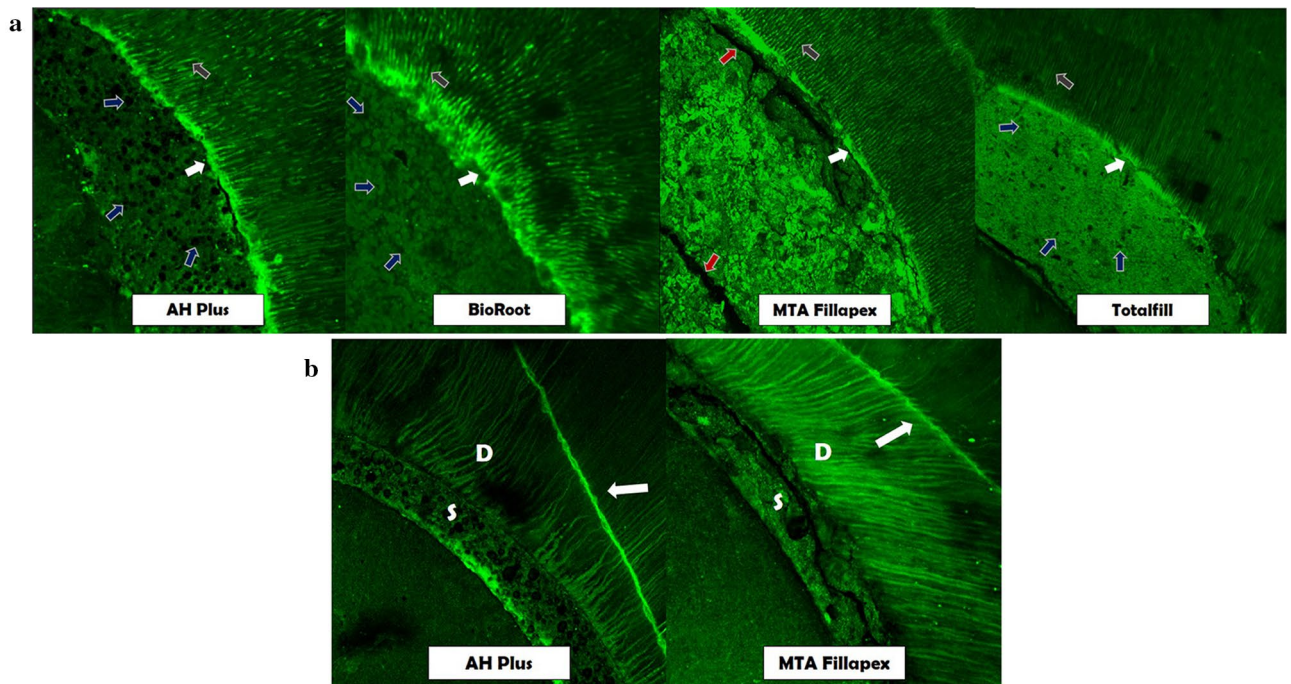
Figure 4. Representative fluorescence-mode CLSM images of sealer-dentin interface demonstrated by Orange G added to the test sealers; (a) showing a richly dye-infiltrated layer at the sealer-dentin interface marked with white arrows, sealer penetration inside dentinal tubules marked with grey arrows, porosity of sealers with blue arrows and cracks on sealer mass with red arrows; (b) cracks indicated by fluorescent radial lines on dentin (D) marked by white arrows and on the sealer (S) for MTA Fillapex indicated with red arrows.

Confocal laser scanning microscopy (CLSM). The sealer to dentin interface for the different sealers used is shown in Fig. 4. Micrographs are shown for each sealer type.

Irrespective of the irrigation protocol, all sealers penetrated into the dentinal tubules (marked with grey arrow in Fig. 4a). A rich dye infiltrated zone appeared at the tooth to sealer interface (marked with white arrow in Fig. 4a). This was more marked in the non-chelator groups (NaOCl and saline) for AH Plus. At HCSCs-dentin interface the dye infiltrated zone was seen in Protocol A (NaOCl); Protocol B/D (NaOCl; NaOCl/chelator) for BioRoot; Protocol A (NaOCl/EDTA/NaOCl), Protocol D (NaOCl/EDTA-BC) and Protocol G (saline) for MTA Fillapex and Protocol B/D (NaOCl/chelator), Protocol F (EDTA-BC) and Protocol A/B (NaOCl/EDTA/NaOCl) for Totalfill.

AH Plus showed a good marginal adaption for irrigation protocols that included a chelator. The BioRoot and Totalfill also exhibited adequate marginal adaptation, except for Protocol A (NaOCl/EDTA) for the former, and Protocols A (NaOCl; NaOCl/EDTA) and F (EDTA-BC) for the latter. AH Plus displayed more material porosity than BioRoot and Totalfill (marked with blue arrow in Fig. 4a). MTA Fillapex displayed voids and cracks on its surface (marked with red arrow in Fig. 4a,b), with better interaction with dentin for Protocols B/D (NaOCl/chelator), E/F (chelators) and G (saline).

Irrigation protocols that contained chelator induced cracks (marked with white arrows) on root dentin when obturated with AH Plus and MTA Fillapex (Fig. 4b). The HCSCs exhibited poor adaptation in contact with the gutta-percha.
